DURABILITY OF CONCRETE STRUCTURES

Investigation, repair, protection

EDITED BY GEOFF MAYS

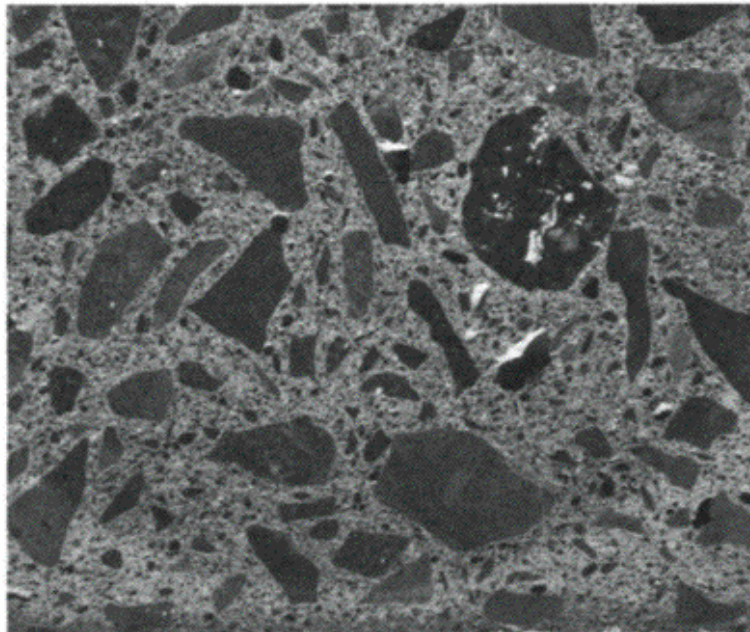
Fig. 2.1 Polished surface of concrete.

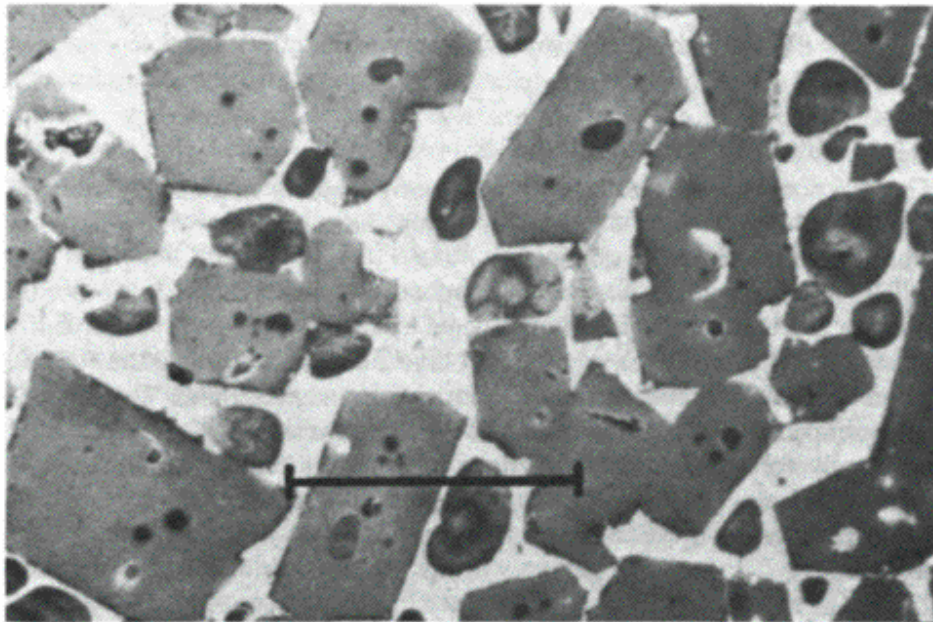
Fig. 2.2 Photomicrograph of cement clinker (bar is 100 μm).

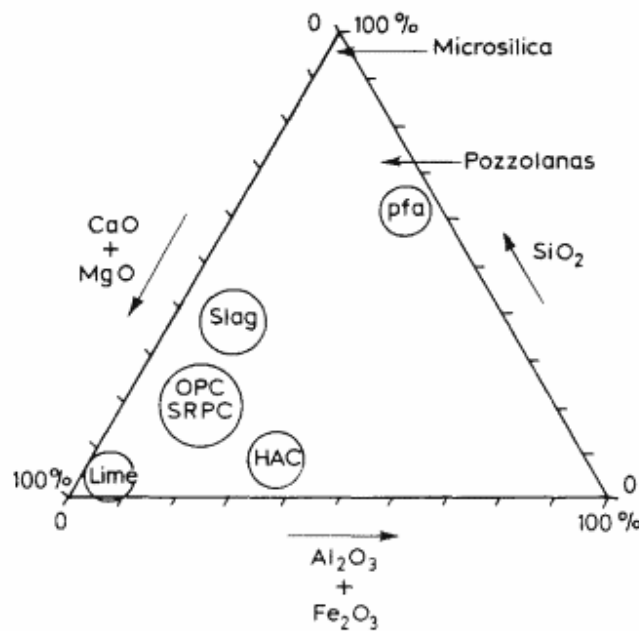
Fig. 2.3 Triangular diagram of common cementitious materials.

calcium aluminates and contains only small amounts of calcium silicates. Figure 2.3 is a triangular diagram which demonstrates that all the cementitious materials commonly used in concrete or mortar are broadly related.

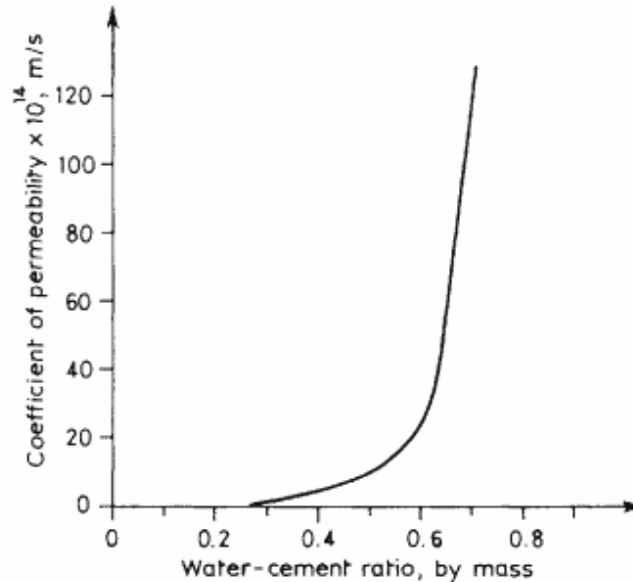
Fig. 2.4 Typical relationship between permeability and water-cement ratio in concrete.

The capillary porosity in the paste makes concrete permeable to liquids and gases as demonstrated in Fig. 2.4. The capillary porosity is not the only route by which gases and liquids can permeate through concrete because

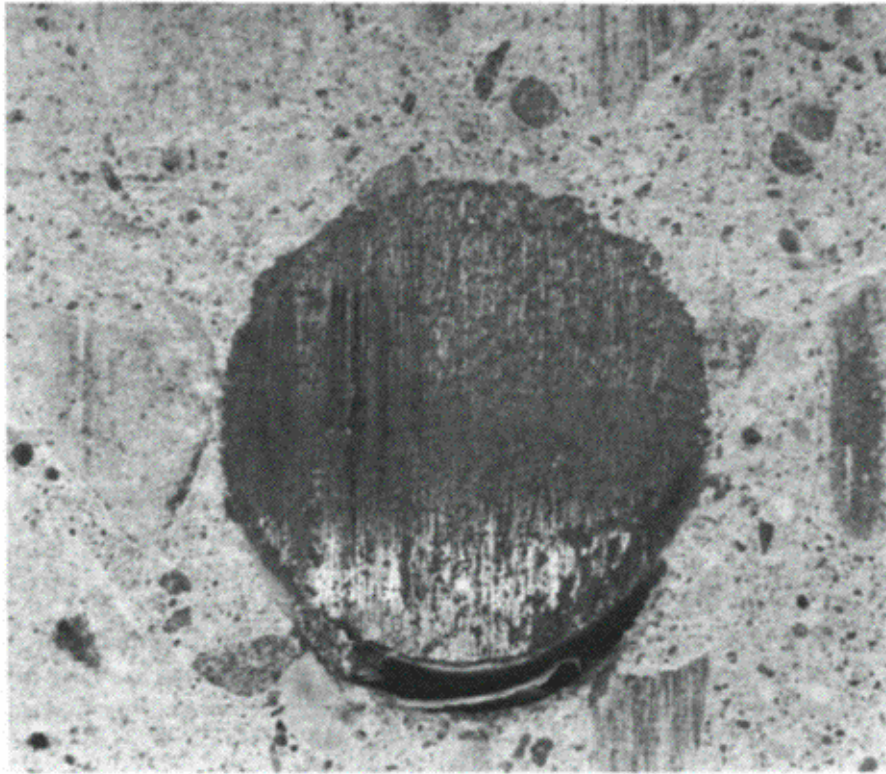
Fig. 2.5 Void under reinforcing bar due to plastic settlement of fresh concrete.

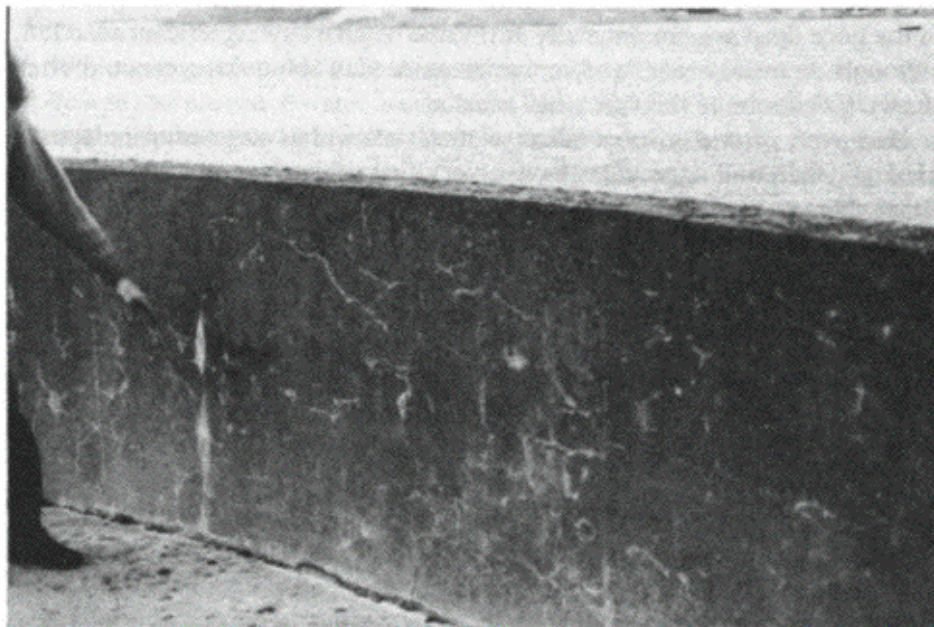
Fig. 2.8 Unrestrained map cracking on parapet wall due to alkali-silica reaction.

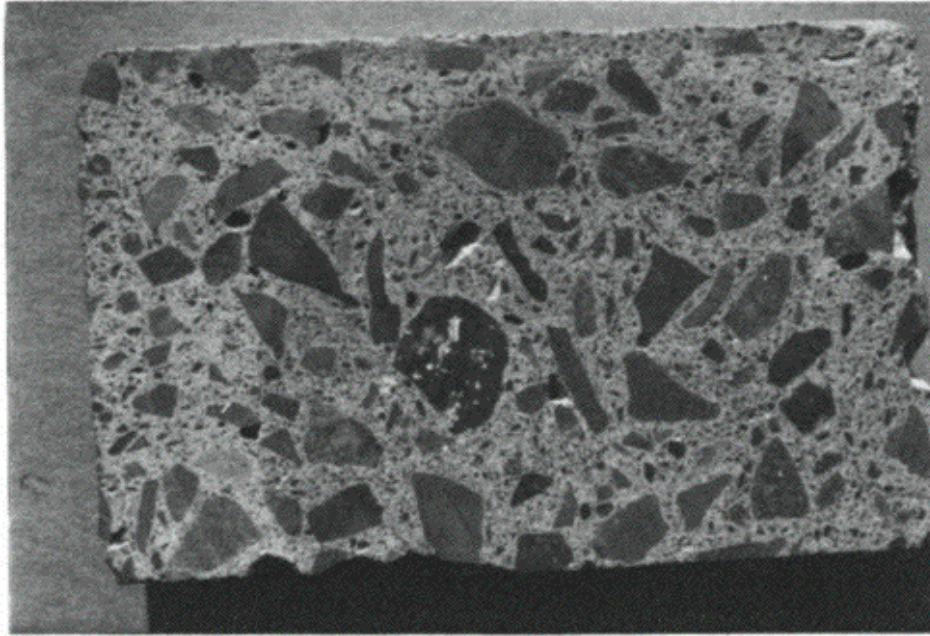
Fig. 2.9 Section of concrete cement-rich (upper) surface.

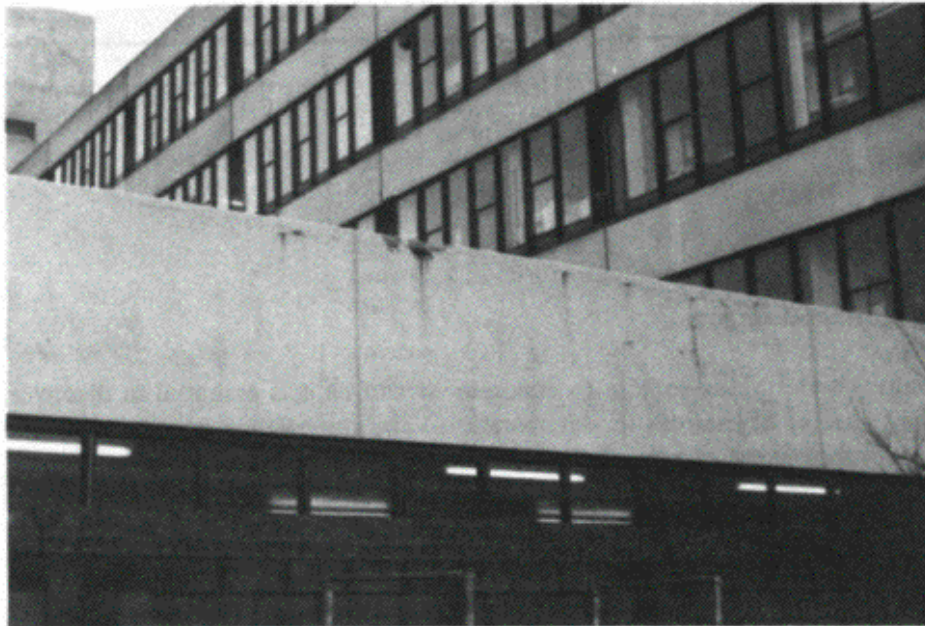
Fig. 3.1 Deterioration of repair to calcium-chloride-affected concrete after four years. Incorrect diagnosis and specification.

Well-designed, compacted and cured reinforced concrete can be a very durable material. However, many of our buildings and structures were constructed at a time when concrete was regarded as a low maintenance or maintenance-free material which would be tolerant of shortcomings in mix design, placing and curing. In addition it was not realized how susceptible poor quality concretes were to deterioration due to poor aggregate selection, attack by de-icing salt or chloride-containing admixtures, atmospheric carbonation etc. There is therefore a continuing and increasing need to undertake the inspection of many of our concrete structures where premature deterioration has occurred, both to determine the need for any repair work and to determine whether additional protection and/or maintenance may be necessary. The purpose of inspection therefore is not only to document the type(s) and extent of deterioration identified but also to investigate the cause(s) of the deterioration and provide guidance on appropriate remedial action to prevent or mitigate against its reoccurrence (Fig. 3.1).

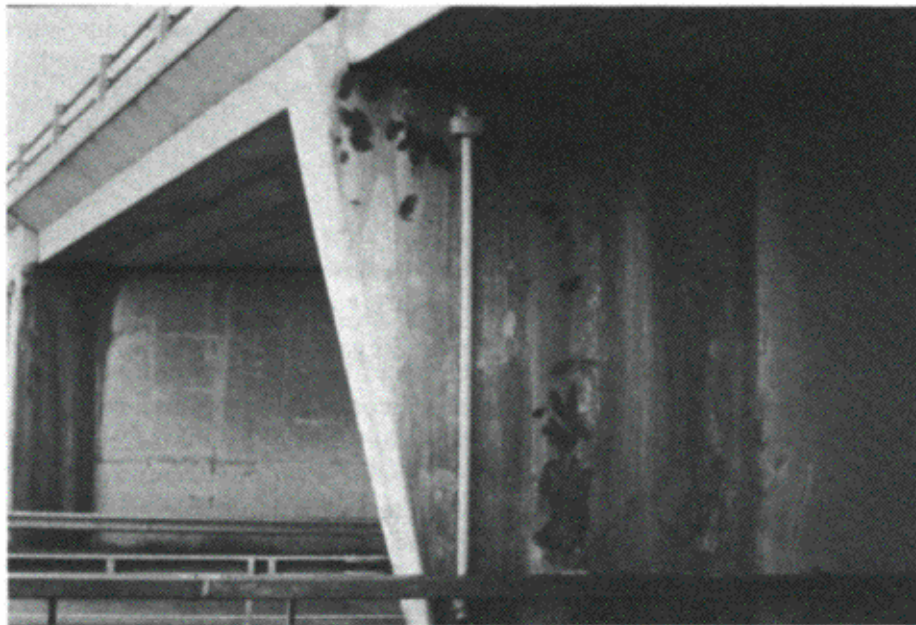
Fig. 3.2 Failure of drainage system on bridge pier/abutment.

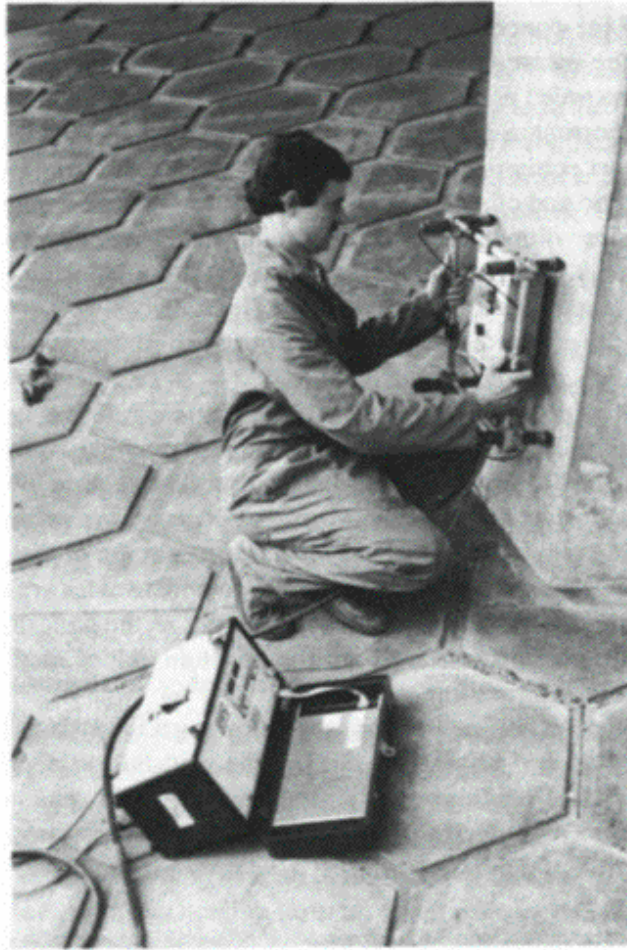
Fig. 3.7 Use of half-cell potential data logger on bridge column.

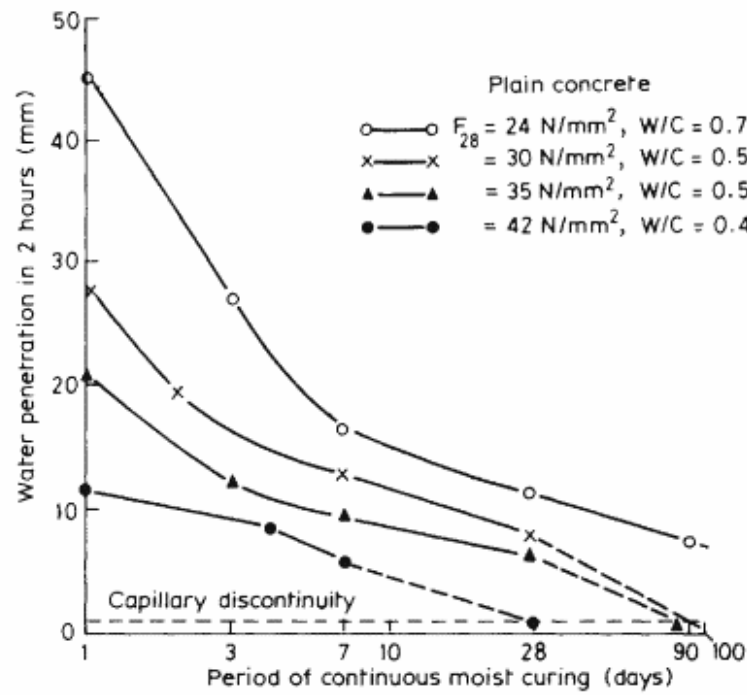
Fig. 3.8 Effect of curing on water penetration by capillary rise for different concrete mixes (after Ho and Lewis, 1984).

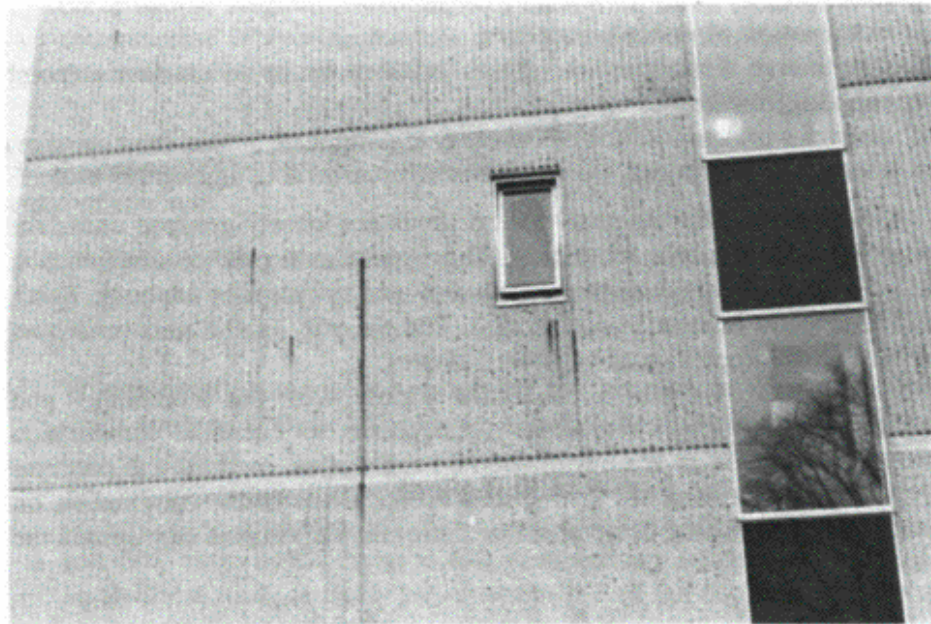
Fig. 3.9 Rust staining due to pyrites on *in-situ* concrete.

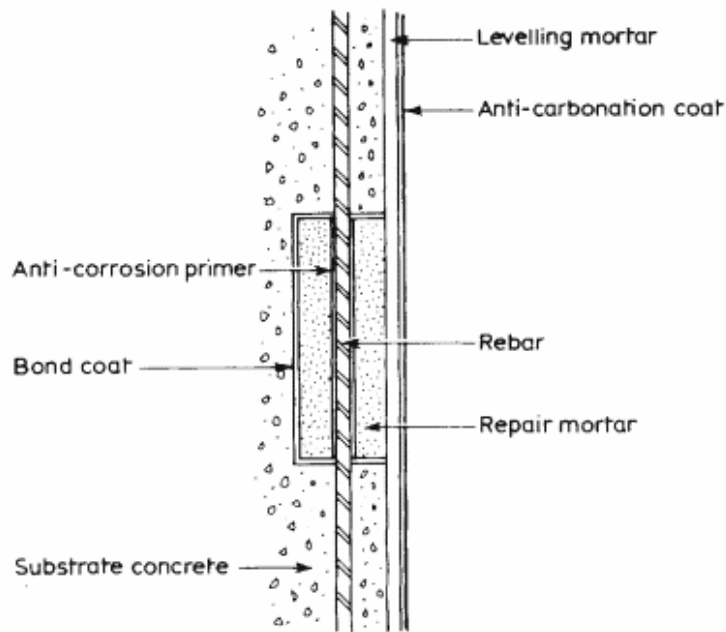
Fig. 4.1 Elements of a cementitious 'repair package'.

bridge to promote good adhesion between the repair mortar and the concrete substrate, an anti-corrosion primer for the steel reinforcement and an anti-carbonation coating to be applied over the whole structure after repair. Before the latter can be applied, however, it will usually be found that a fairing coat or levelling mortar is required to fill in blow-holes and irregularities in the areas of concrete not needing repair, in order to create a uniform and tightly closed surface upon which to apply the anti-carbonation coating (Fig. 4.1).

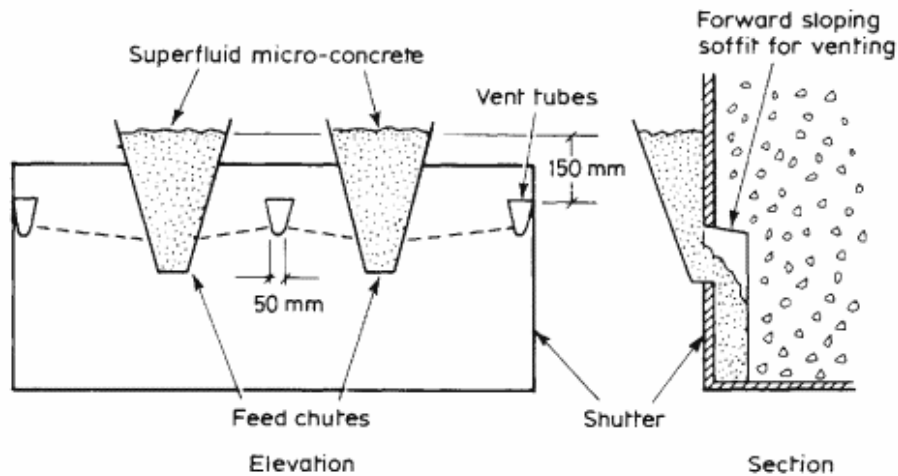
Fig. 4.4 Placing of superfluid micro-concrete in a vertical section.

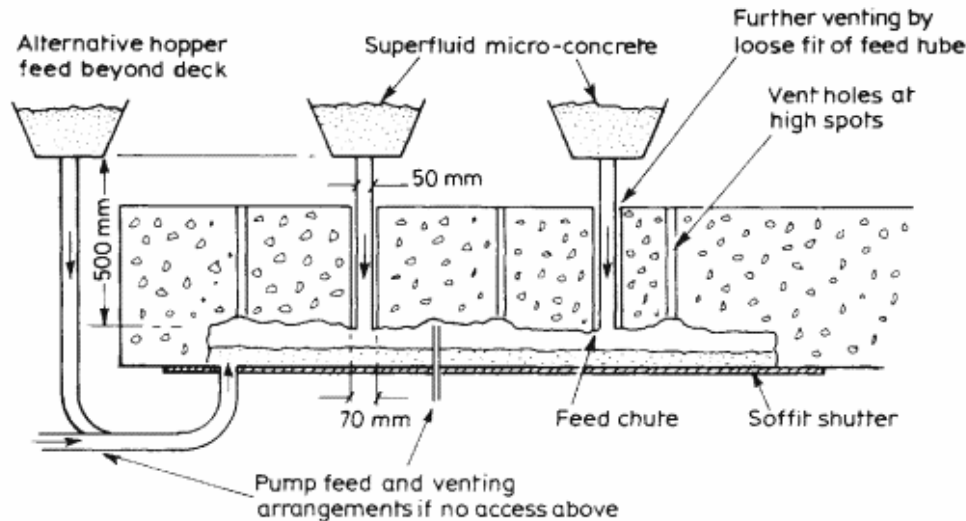
Fig. 4.5 Placing of superfluid micro-concrete to a soffit.

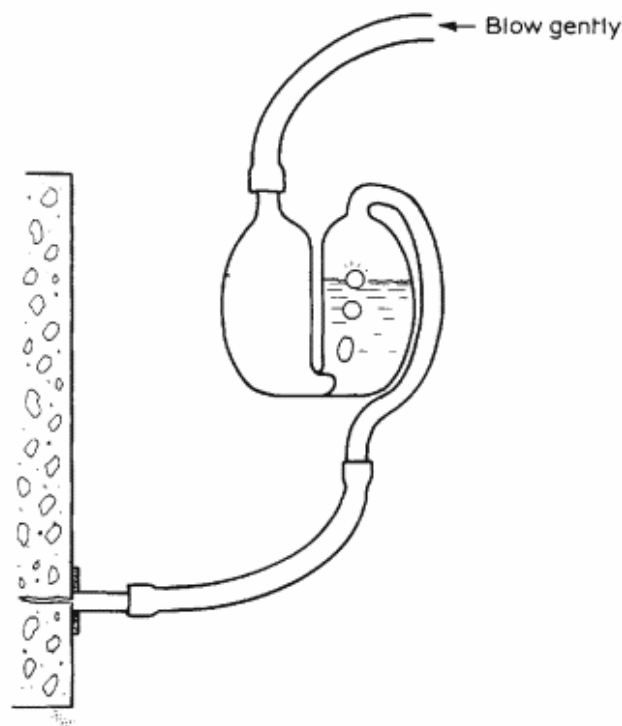
Fig. 4.6 Bubbler, made from wine-making air-lock. Stream of bubbles through the water indicates a clear passage through injection point and through crack to an outlet.

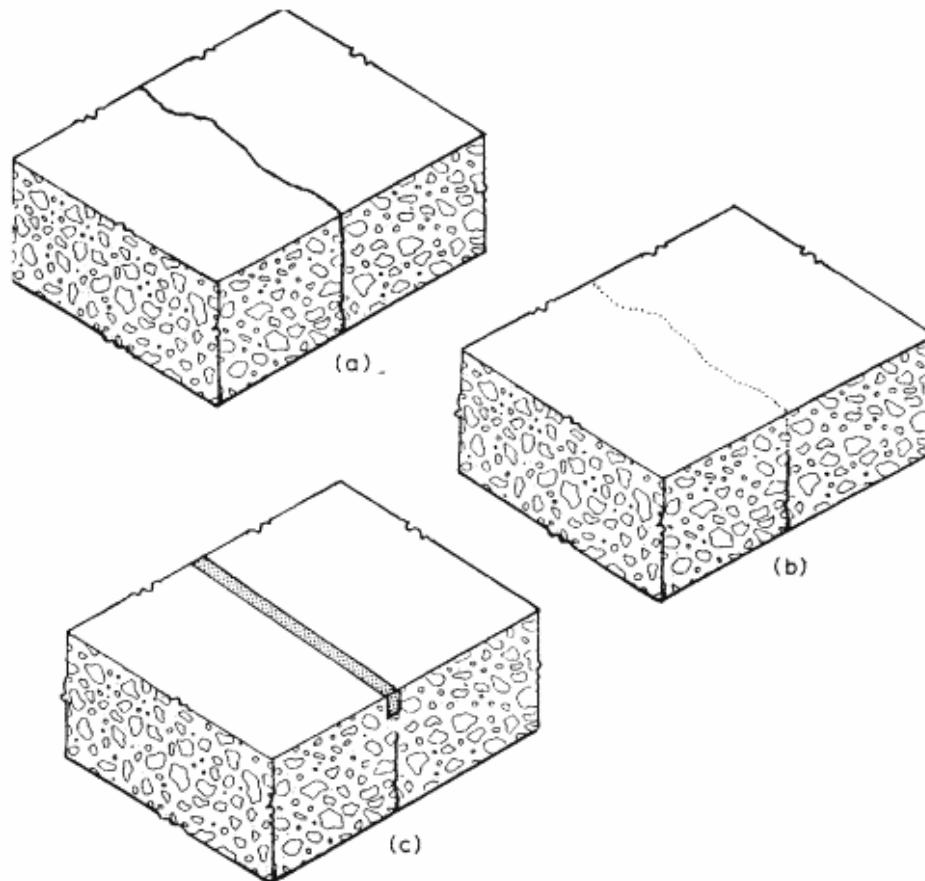
Fig. 4.7 Repair of a 'live' crack, (a) Cracked slab, (b) Crack partially rebonded by resin injection to controlled depth (see Fig. 4.8). (c) Crack-control slot cut and filled with flexible sealant. Any further movement will propagate crack to base of slot, thus permitting movement but keeping crack sealed against ingress.

depth of rebond is required, e.g. in the repair of a live crack (Fig. 4.7). If the crack extends the full depth of a member but the far side is inaccessible, it is necessary to limit the travel of the resin to approximately the depth of the member, otherwise a great quantity of resin may be wasted and the crack may never be filled. The technique for achieving this is shown in Fig. 4.8 and depends upon the use of a thixotropic resin. The spacing between the injection points should be five-sixths of the depth that the resin is required to reach. It can be seen from the sketch that a free-flowing resin could go to waste (and coring of floor slabs treated by gravity feeding of such resins has proved the point), whereas a thixotropic resin will not drain under the influence of gravity but will fan out in a semicircle travelling sideways as well.

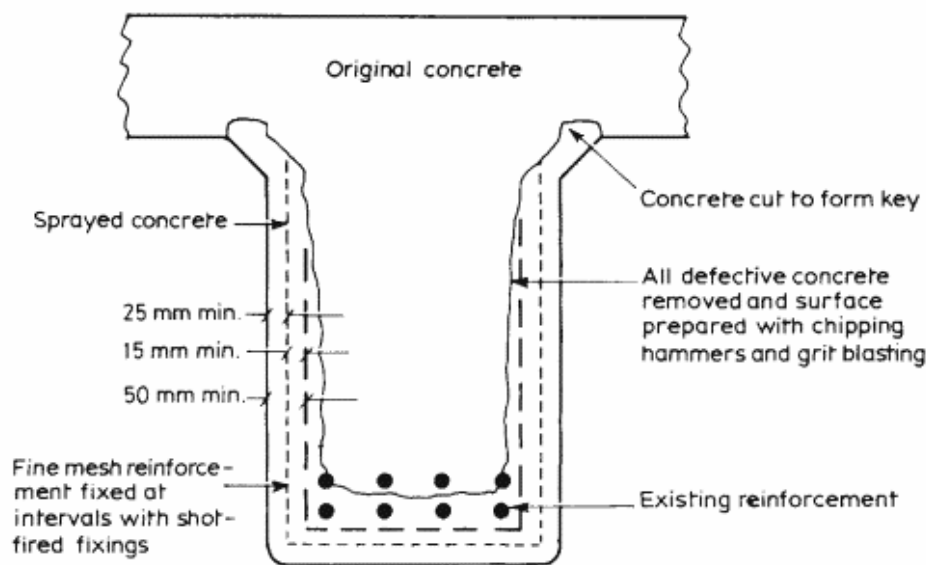
Fig. 4.9 Beam repair using sprayed concrete.

Where damage due to reinforcement corrosion or fire has caused widespread spalling, the original section can be restored using sprayed concrete. Figure 4.9 shows typical details for the repair of a fire-damaged downstand beam.

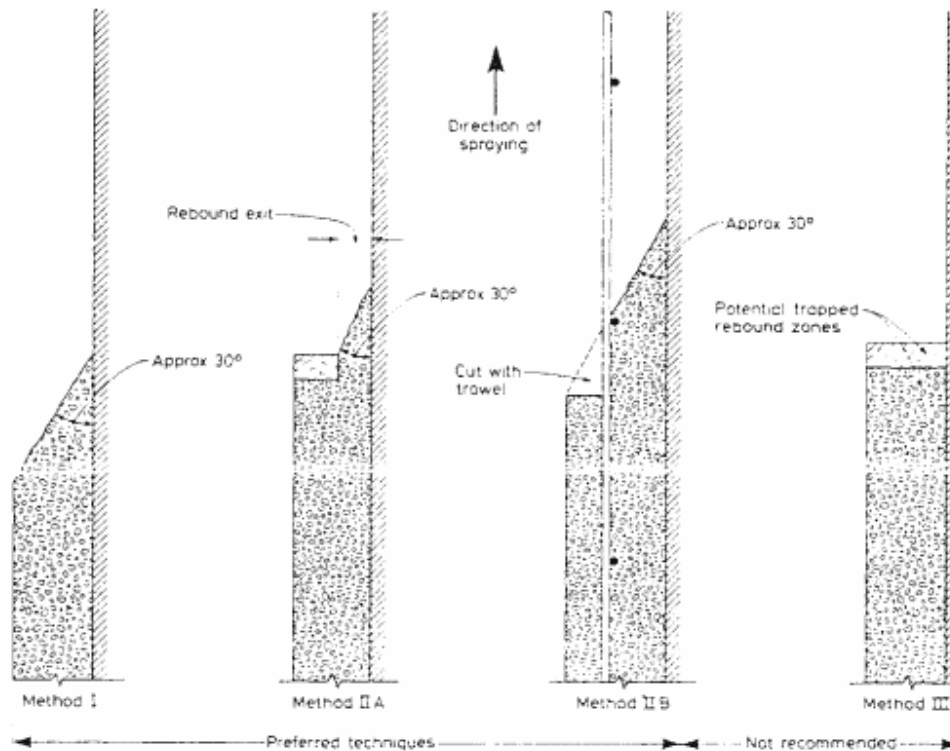
Fig. 4.10 Methods of forming construction joints in sprayed concrete (Concrete Society, 1979)

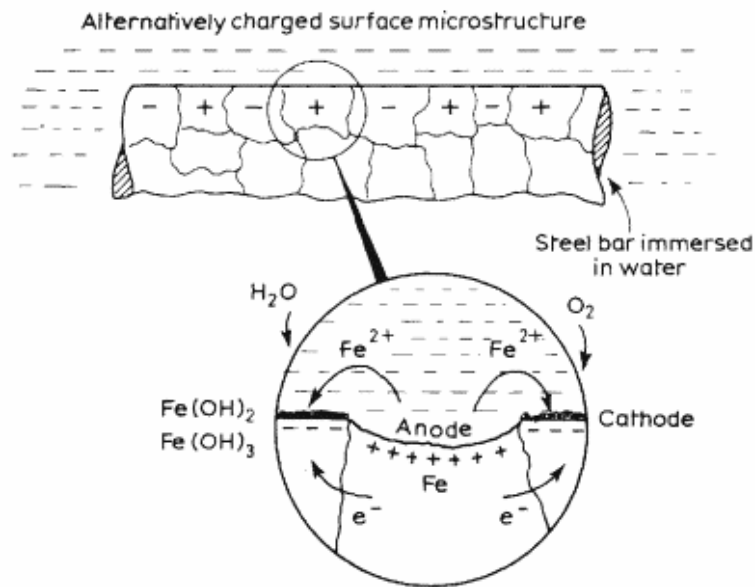
Fig. 5.1 How corrosion occurs:

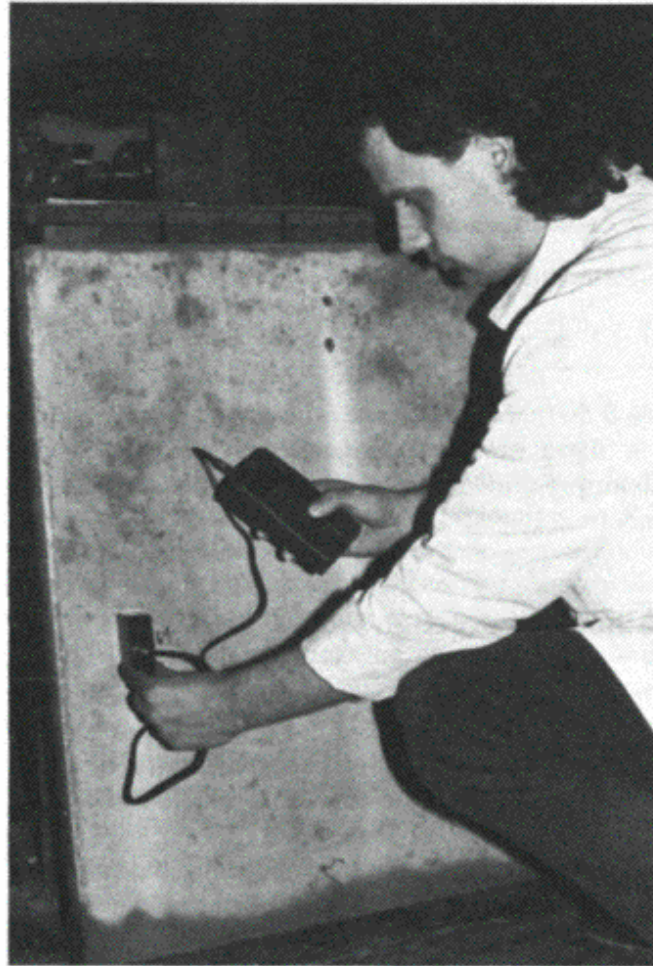
Fig. 5.2 A resistivity meter developed for concrete.

Instrumentation is now available to test the resistivity of concrete on site (Fig. 5.2) and to measure the electrochemical state of reinforcing steel (Fig. 5.3): The anodic (corroding) and cathodic (protected) areas of a structure can be assessed by measuring resistivity and, in conjunction with chemical analyses, the aggressivity of the conditions to which the structural concrete has been exposed can be deduced. Techniques for quantification of metal loss over specific sections of reinforcement have not yet been fully developed

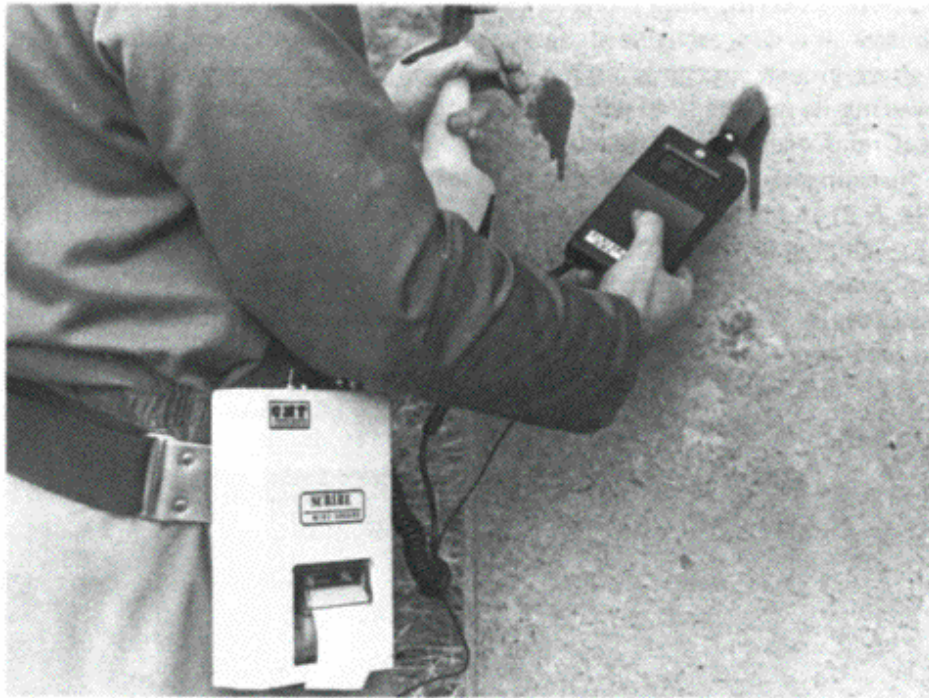
Fig. 5.3 Potential measurement and logging (courtesy of CMT Ltd, Raynesbury, Derby)

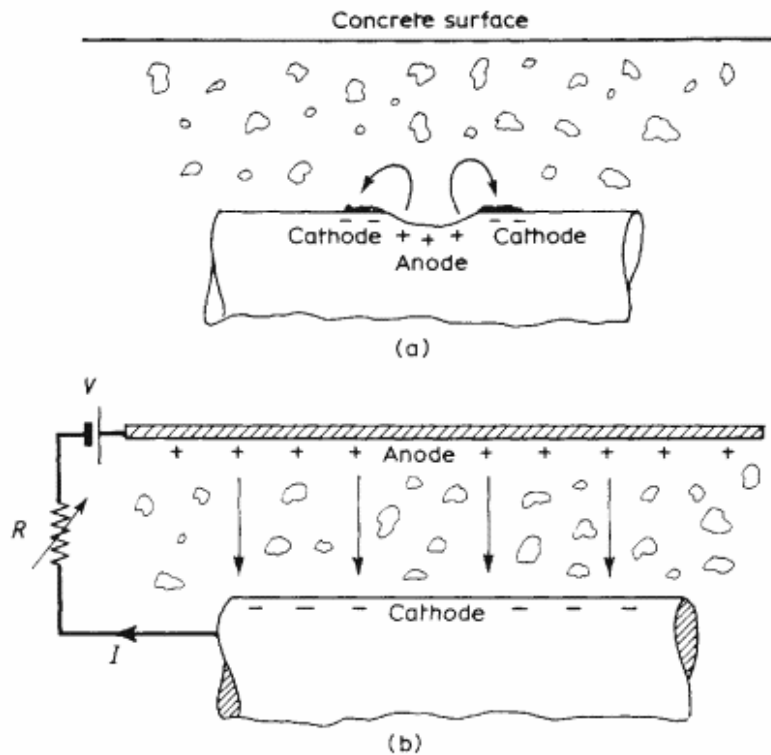
Fig. 5.4 (a) A freely corroding reinforcement bar (see Fig. 5.1 for details),
(b) A cathodically forced surface.

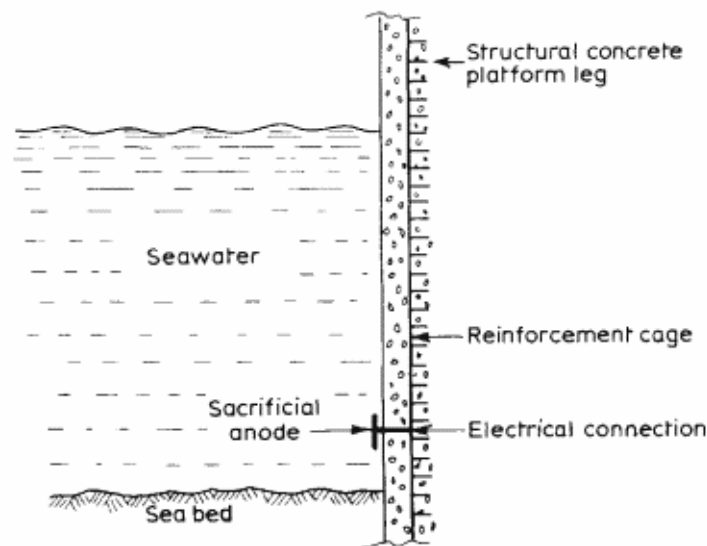
Fig. 5.5 Sacrificial anode(s) on a platform leg.

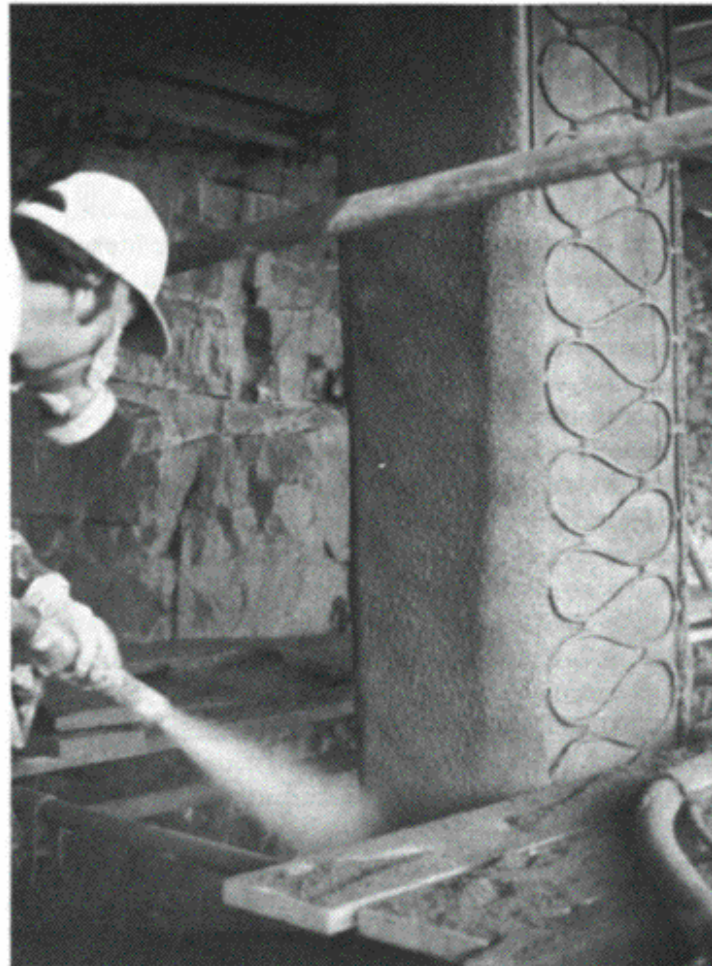
Fig. 5.6 Fixed anode cover coat on bridge column (courtesy of Raychem Ltd, Swindon, Wilts.).

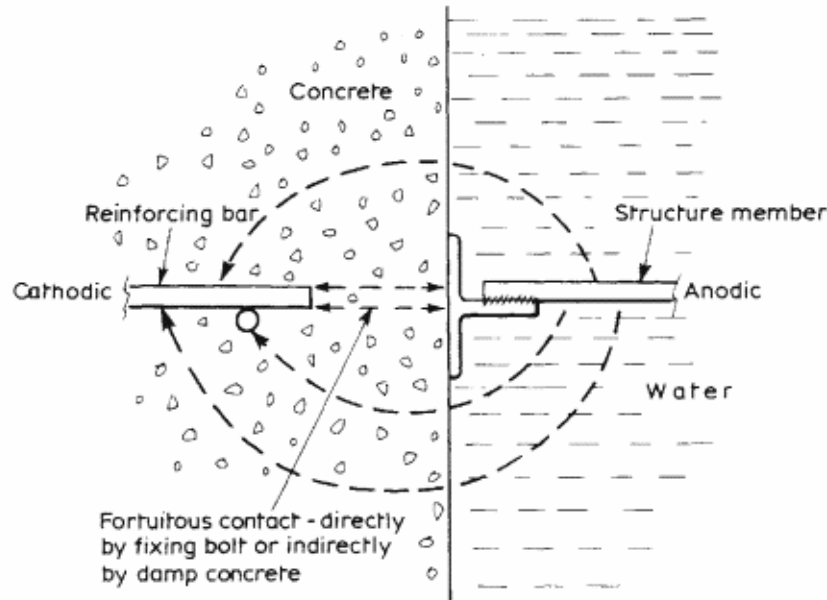
Fig. 5.8 A created corrosion cell in concrete.

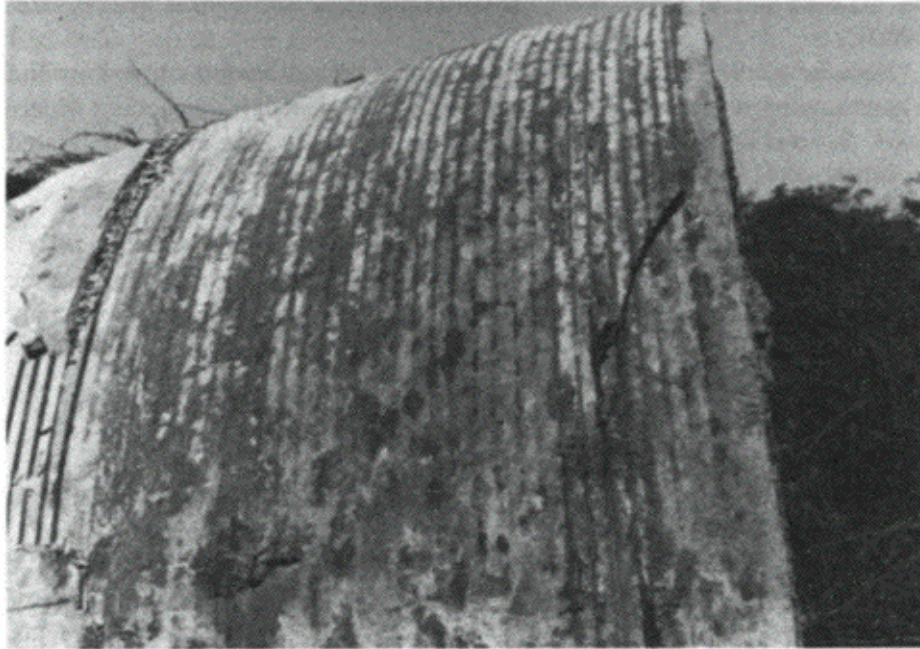
Fig. 5.9 Stray current attack causing premature failure of prestressing wires on concrete pipe.

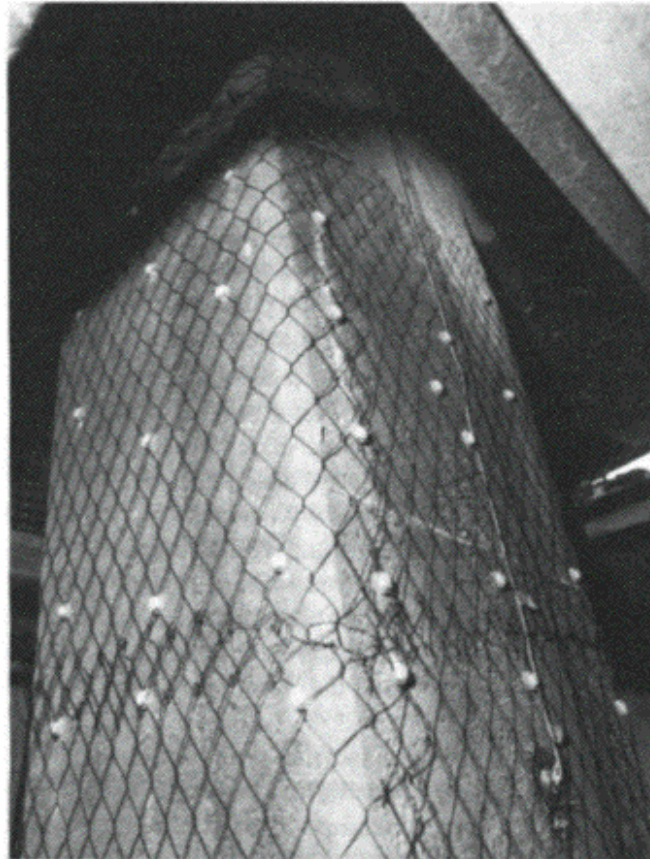
Fig. 5.10 Metal oxide ('chicken wire') mesh fixed to bridge column (courtesy of ICI Chemicals & Polymers, Runcorn, Cheshire).

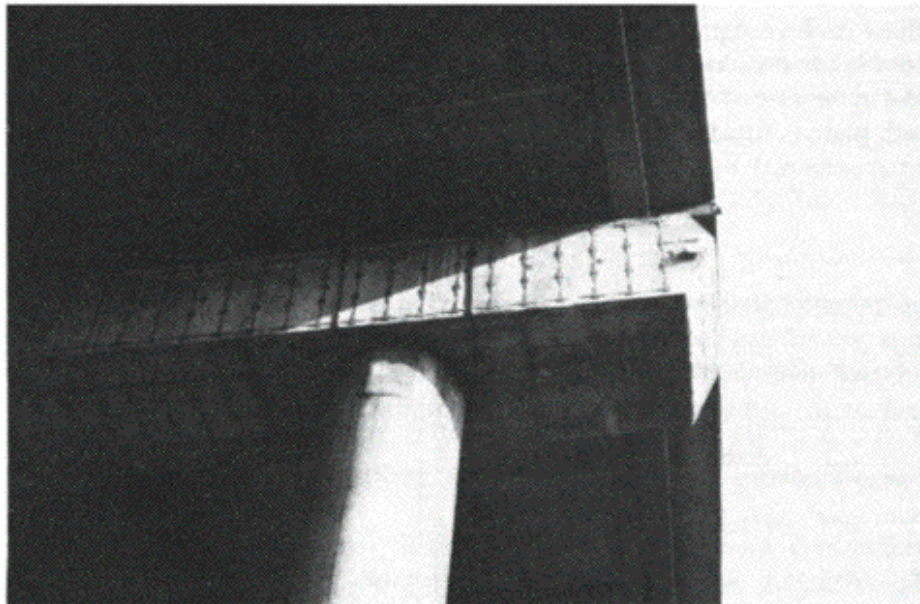
Fig. 5.11 Ceramic plates fixed to bridge beam (courtesy of Ebonex Technologies Inc., California, USA).

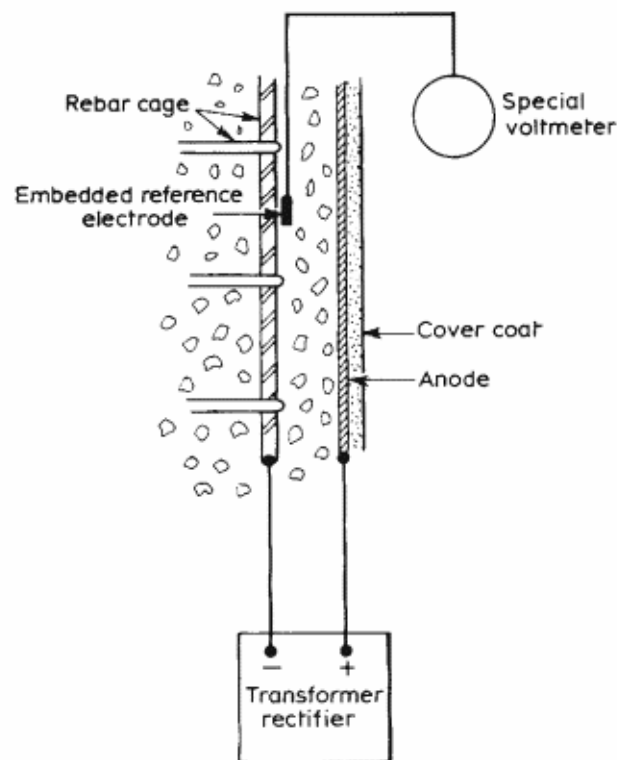
Fig. 5.12 The basic cathodic protection circuit layout.

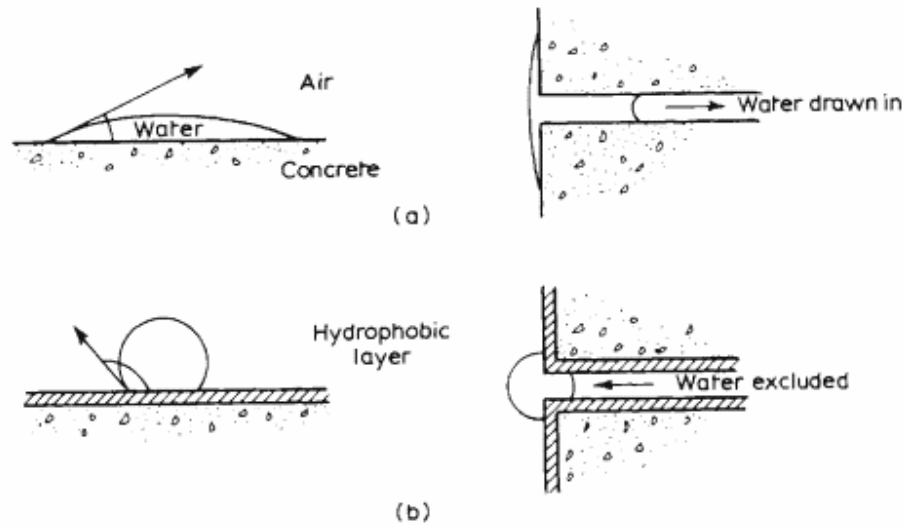
Fig. 5.14 Effects of a hydrophobic pore-lining surface treatment (Edmeades and Hewlett, 1985): (a) ordinary concrete, contact angle less than 90°; (b) concrete with water-repellant surface, contact angle greater than 90°.

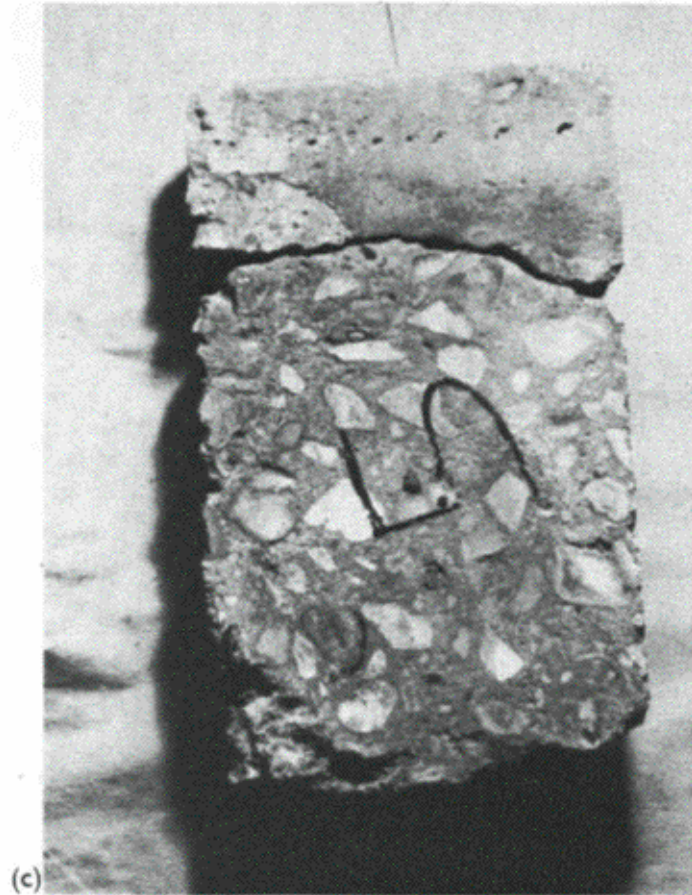
Fig. 5.16 Cores extracted in 1983 from a 1930s reinforced concrete factory building: (a) uncoated concrete from interior surface; (b) concrete coated in 1952; (c) core from an area repaired with mortar and coated in 1952. The cores have been sprayed with phenolphthalein solution; lighter areas indicate depth of carbonation. (Courtesy of W.J. Leigh & Co.)

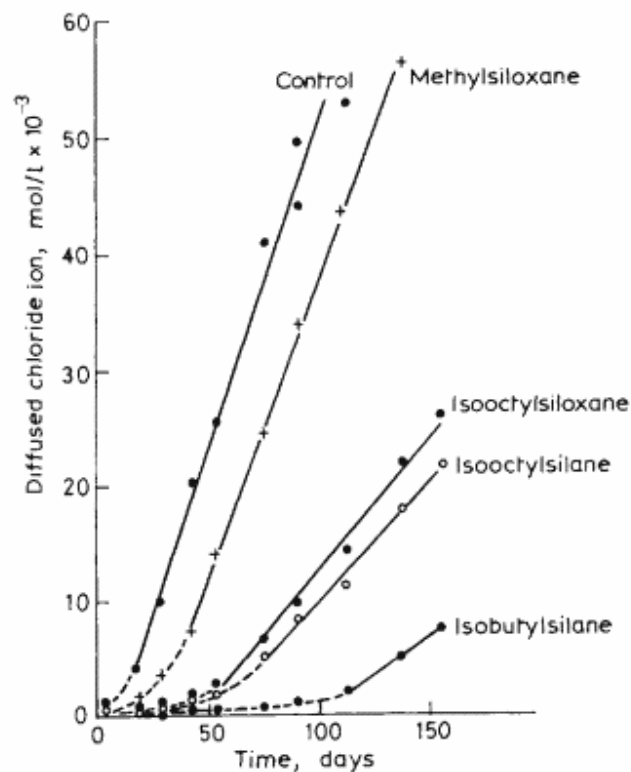
Fig. 5.18 Diffusion of chloride through silane-siloxane-treated concrete (Robinson, 1987) (full line is steady state diffusion).

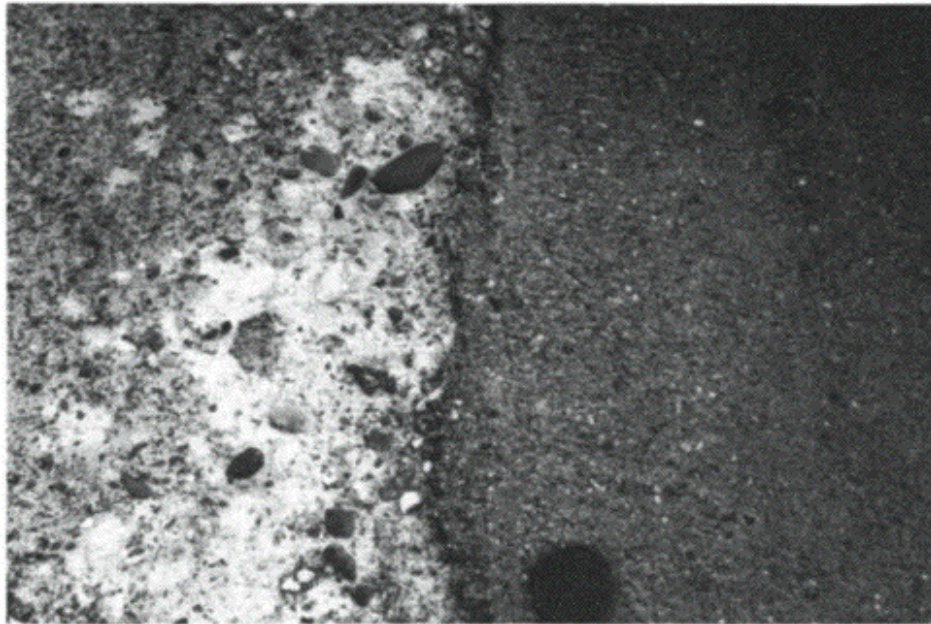
Fig. 5.19 Freeze-thaw effects on silane-treated concrete (right) and untreated concrete (left) on the hard shoulder of a bridge structure in West Germany (courtesy of Dynamit-Nobel)

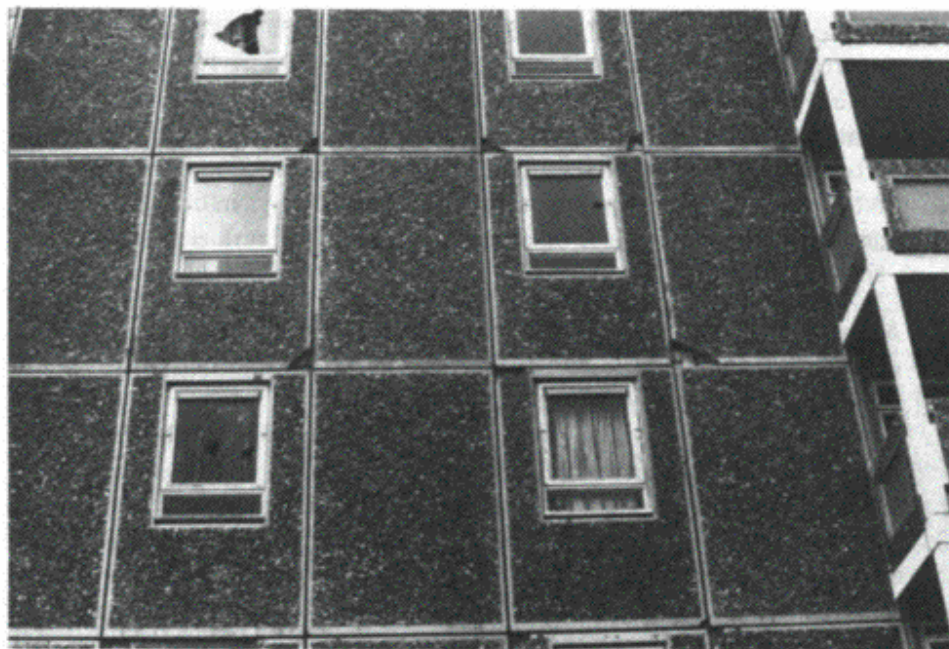
Fig. 7.3 Failure of cladding units at Herbert Willig House

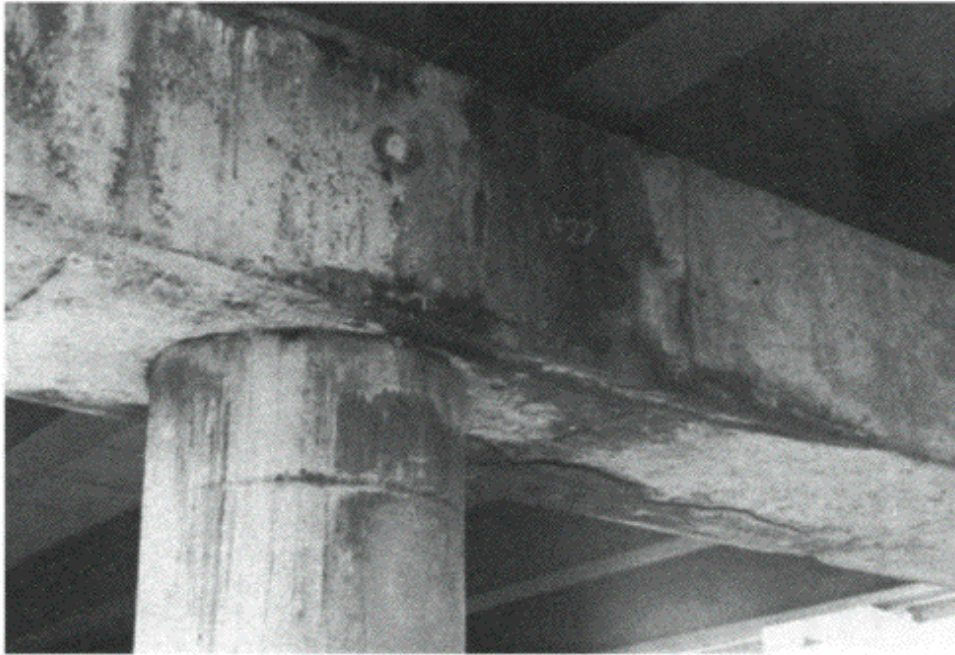
Fig. 8.3 Midlands Links Viaduct substructure.

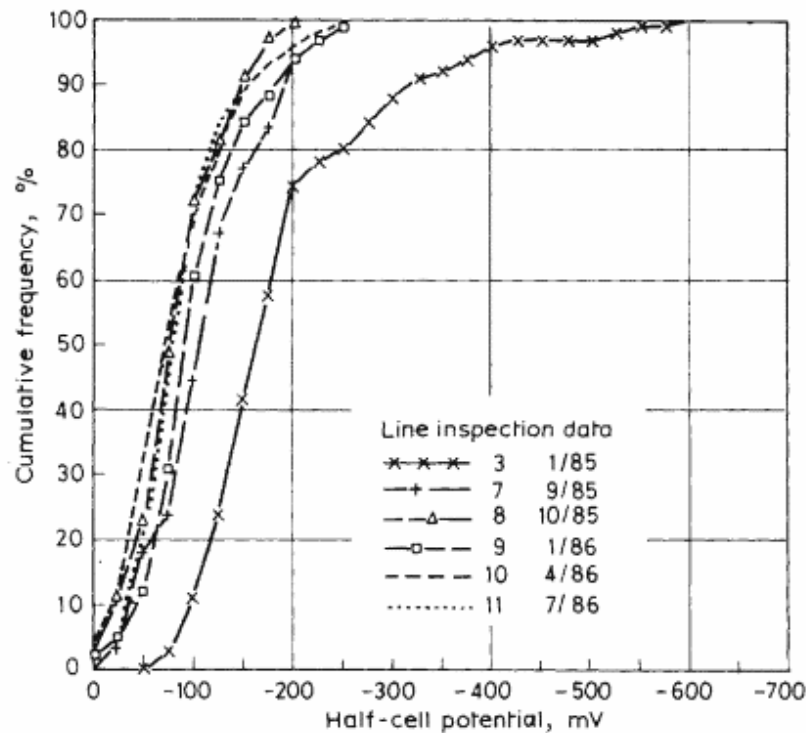
Fig. 8.4 Half-cell potential cumulative frequency plot for motorway crossbeam
