DURABILITY OF CONCRETE STRUCTURES

Investigation, repair, protection

EDITED BY GEOFF MAYS

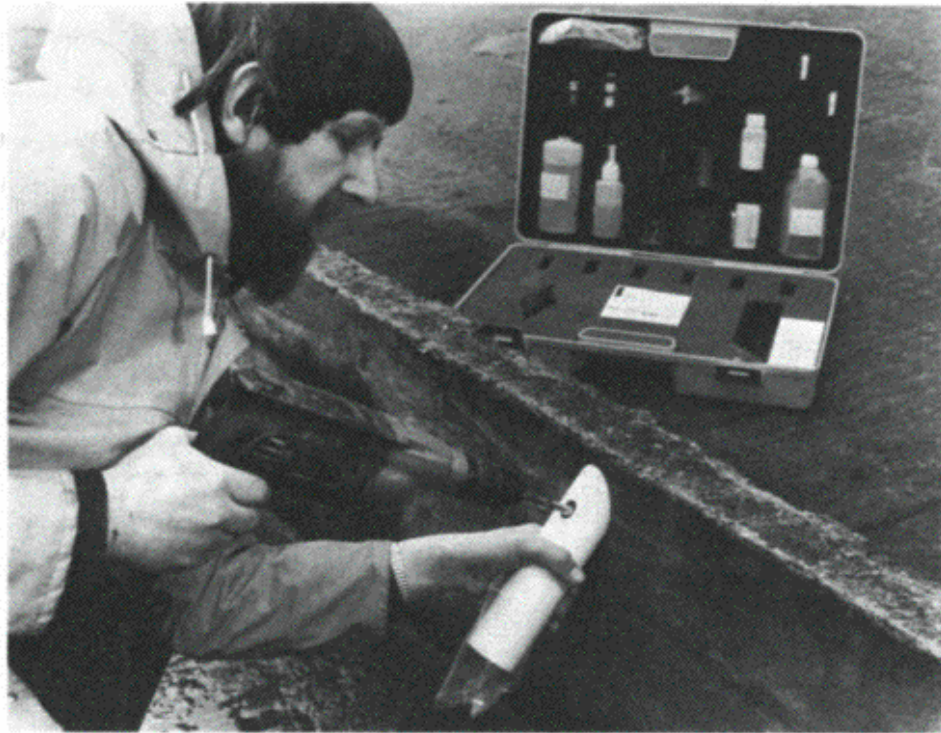
Fig. 9.3 British Rail Research site test kit.

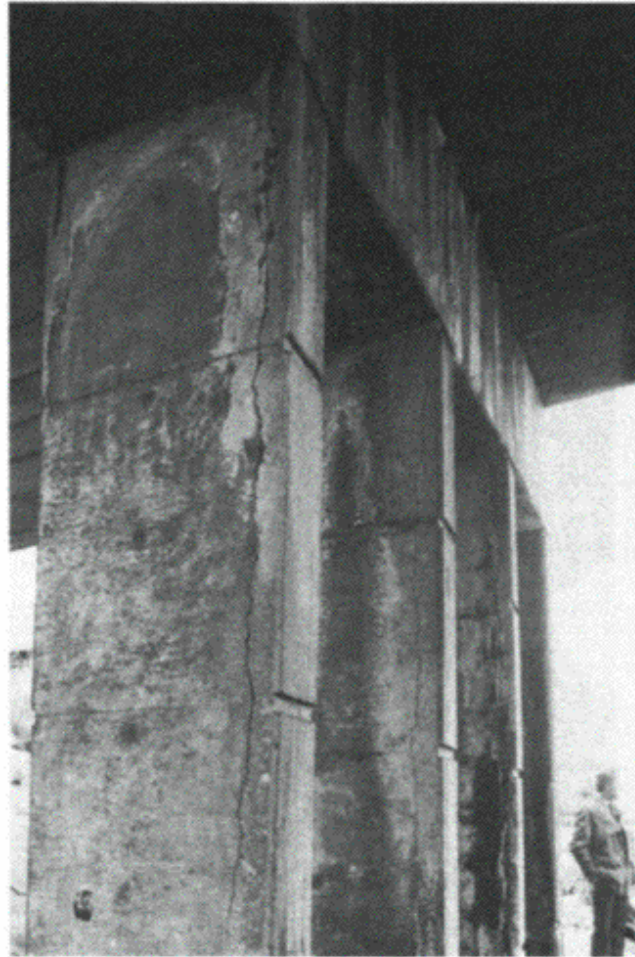
Fig. 9.5 Evidence of water seepage and spalling of columns, Stafford Bridge.

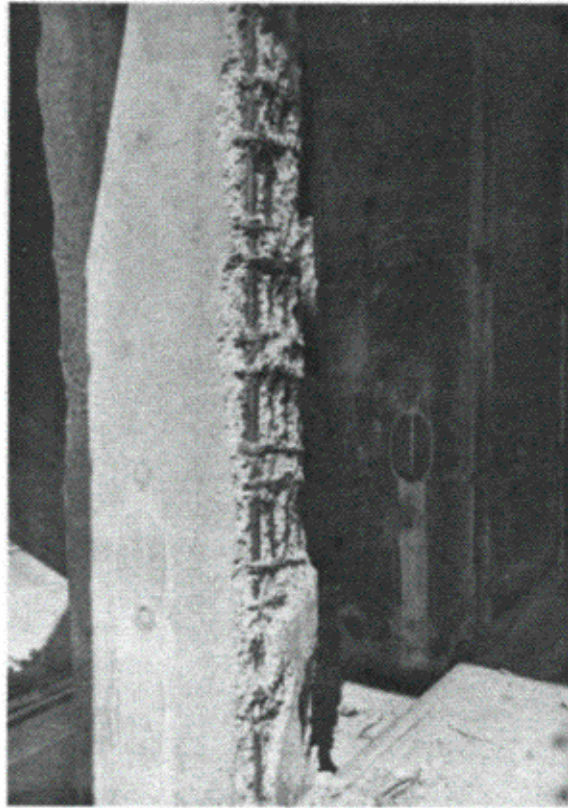
Fig. 9.6 Corrosion damage to column, Stafford Bridge.

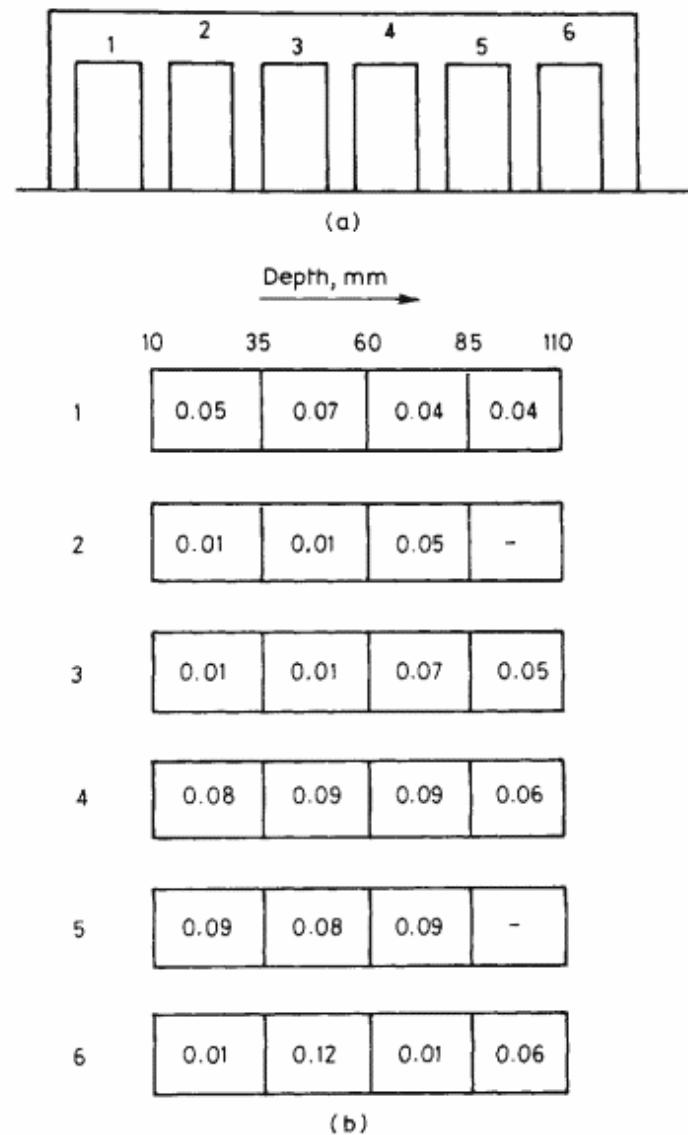
Fig. 9.7 Chloride distribution, crosshead beam, Stafford Bridge:
(a) core location; (b) chloride profiles (per cent by weight).

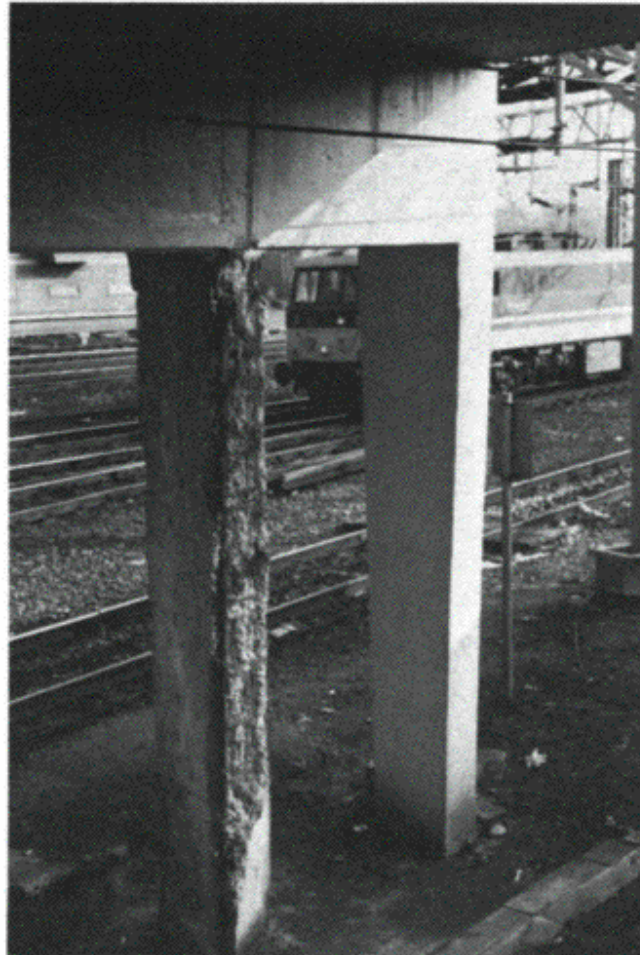
Fig. 9.9 Repaired column, Stafford Bridge.

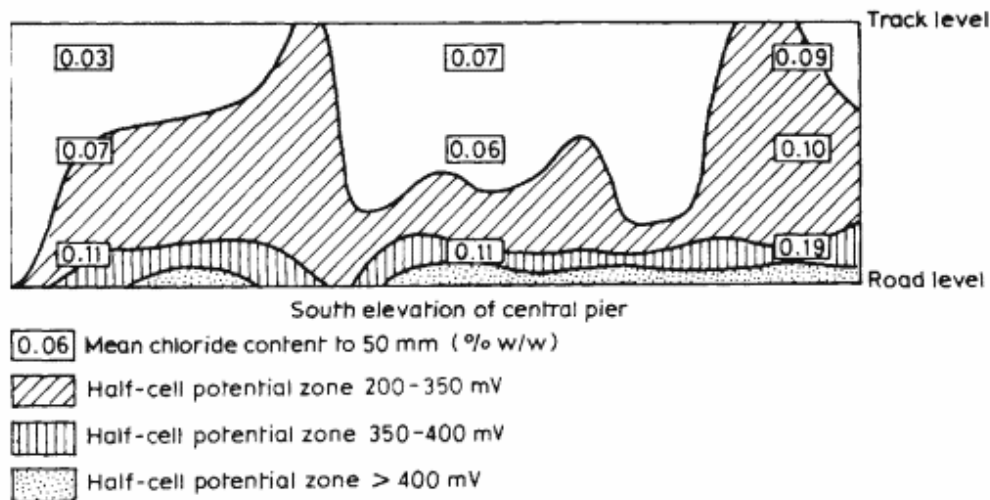
Fig. 9.12 Chloride and half-cell results, Bassaleg Bridge.

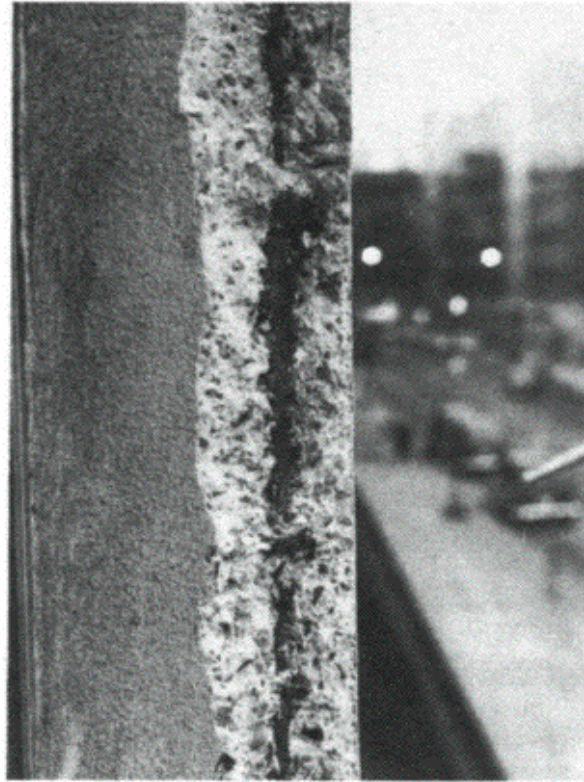
Fig. 9.13 Repair failure on multistorey office block, London.

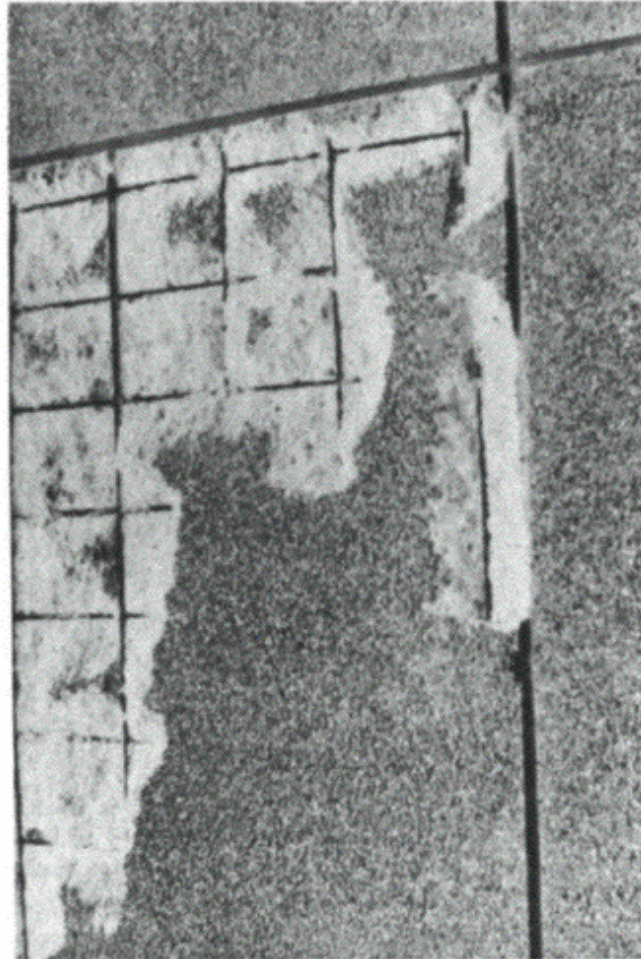
Fig. 9.14 Carbonation at Banbury Station.

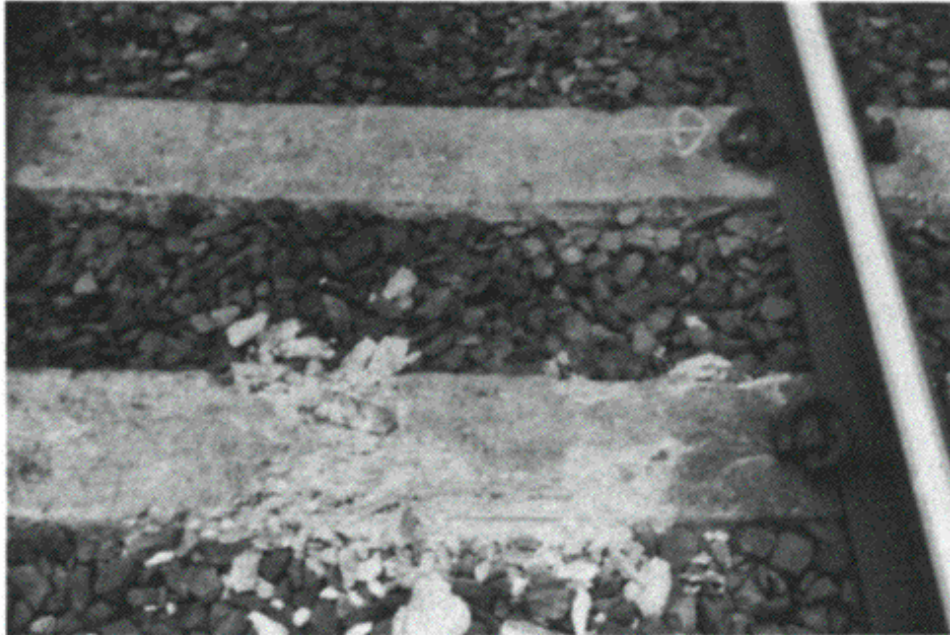
Fig. 9.15 Frost attack, prestressed concrete sleeper.

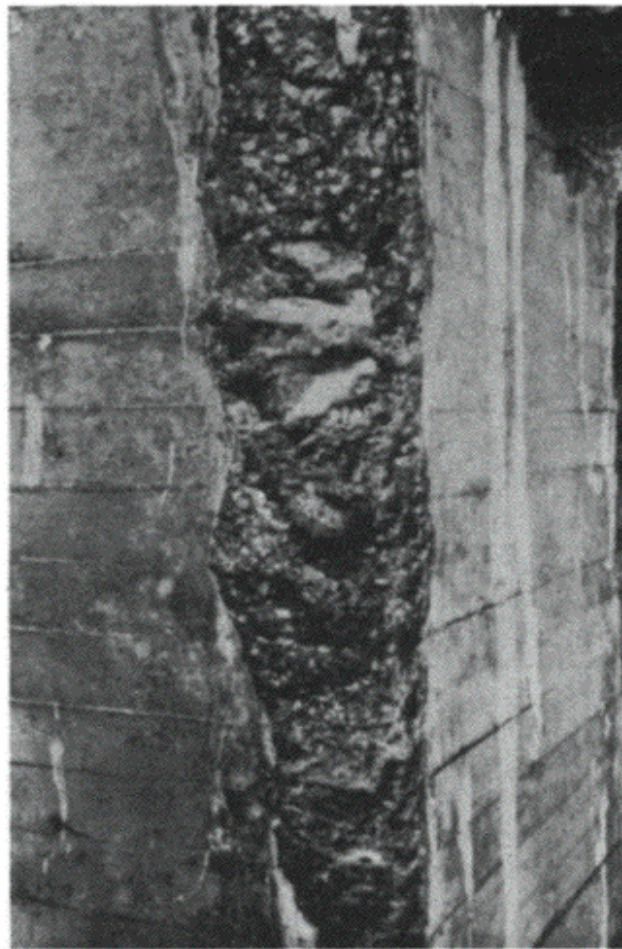
Fig. 9.16 Frost attack, Glenfinnon Viaduct.

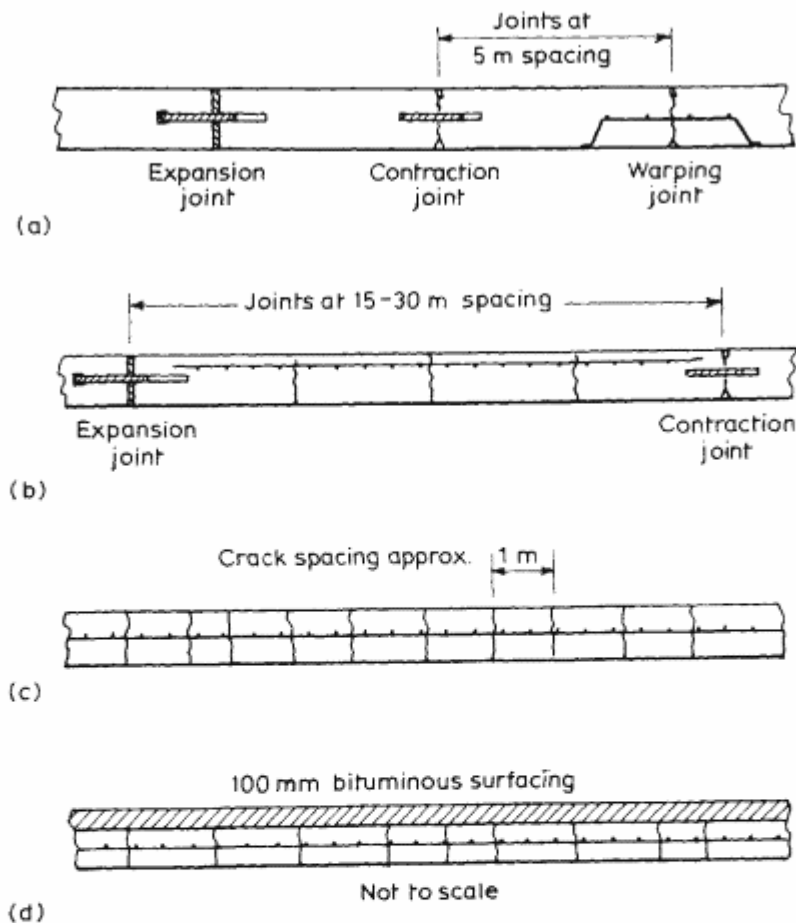
Fig. 10.1 Longitudinal cross-sections of concrete pavements; (a) unreinforced concrete pavement; (b) jointed reinforced concrete pavement; (c) continuously reinforced concrete pavement; (d) continuously reinforced concrete roadbase.

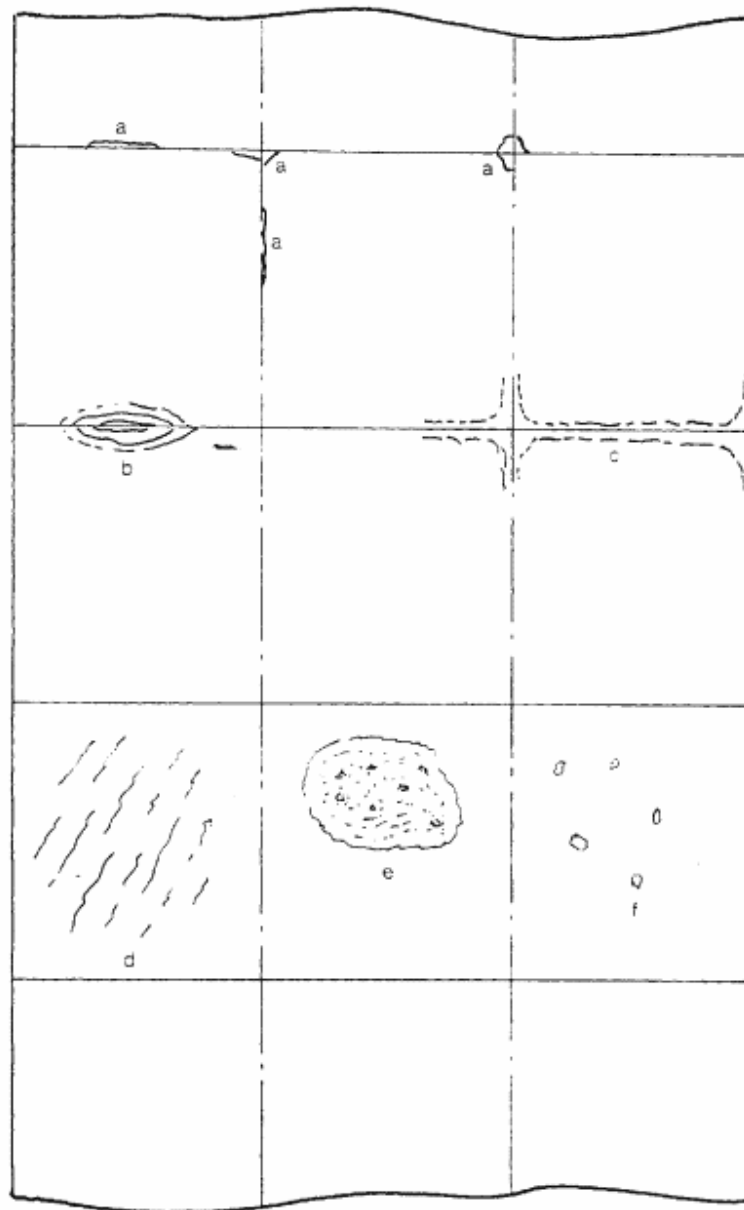
Fig. 10.2 Plan of hypothetical concrete road showing joint and surface defects;
a, shallow spalling; b, deep spalling; c, cracking; d, plastic shrinkage cracking;
e, surface scaling; f, pop-outs.

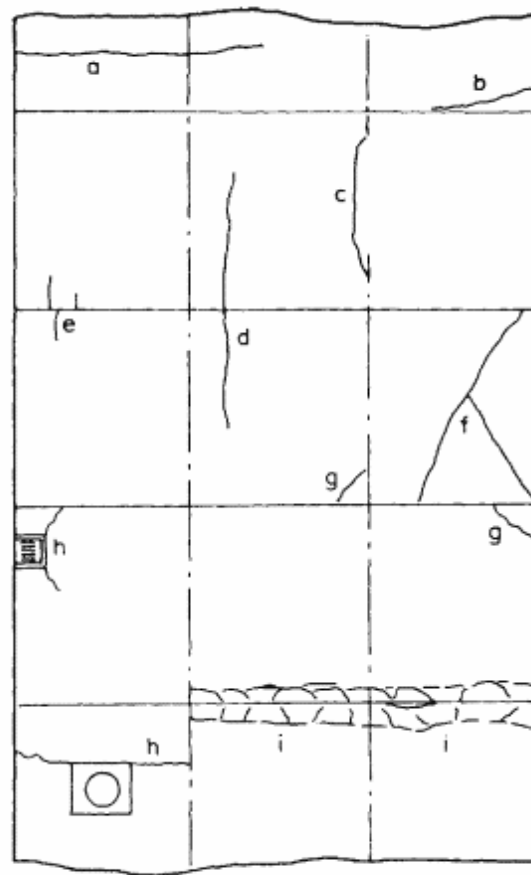
Fig. 10.3 Plan of hypothetical concrete road showing structural defects; a, transverse crack; b, crack at joint; c, longitudinal crack (joint former missing); d, longitudinal crack; e, short longitudinal crack; f, diagonal cracks; g, corner cracks; h, cracks at gulleys and manholes; i, expansion failure (blow-up).

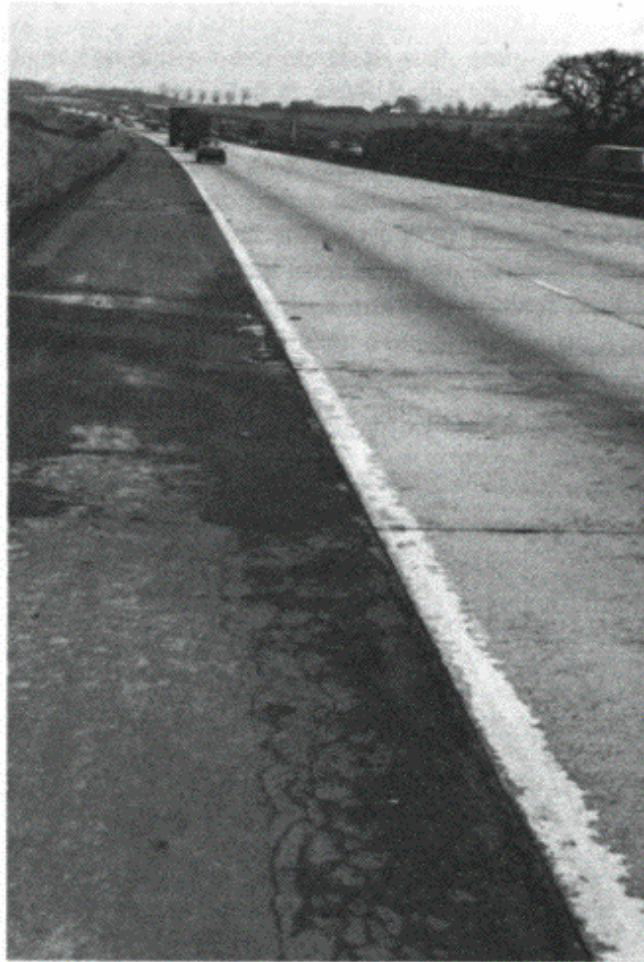
Fig. 10.5 Seepage of water over the hard shoulder from beneath the concrete carriageway.

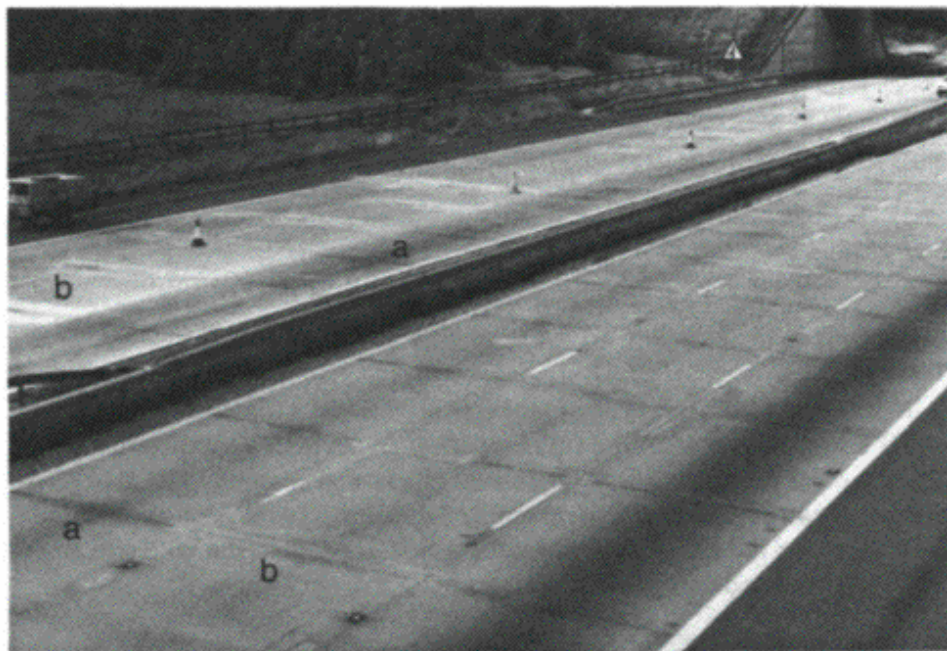
Fig. 10.6 Slip-formed concrete pavement: a, poorly compacted permeable concrete at transverse joints in outer lanes; b, joint aris repairs to most transverse joints in centre and inner lanes.

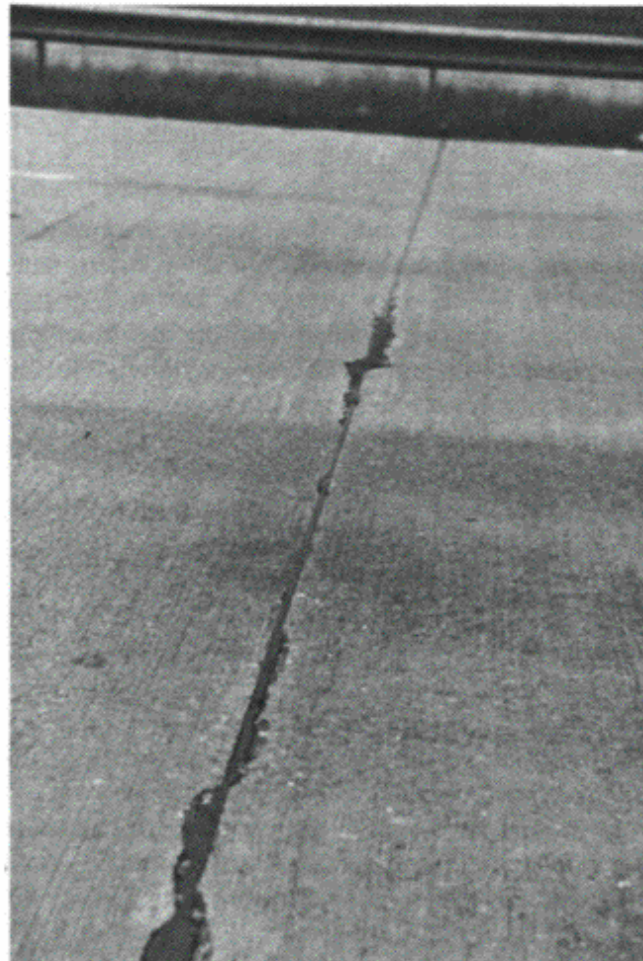
Figure 10.7 Spoiled joint.

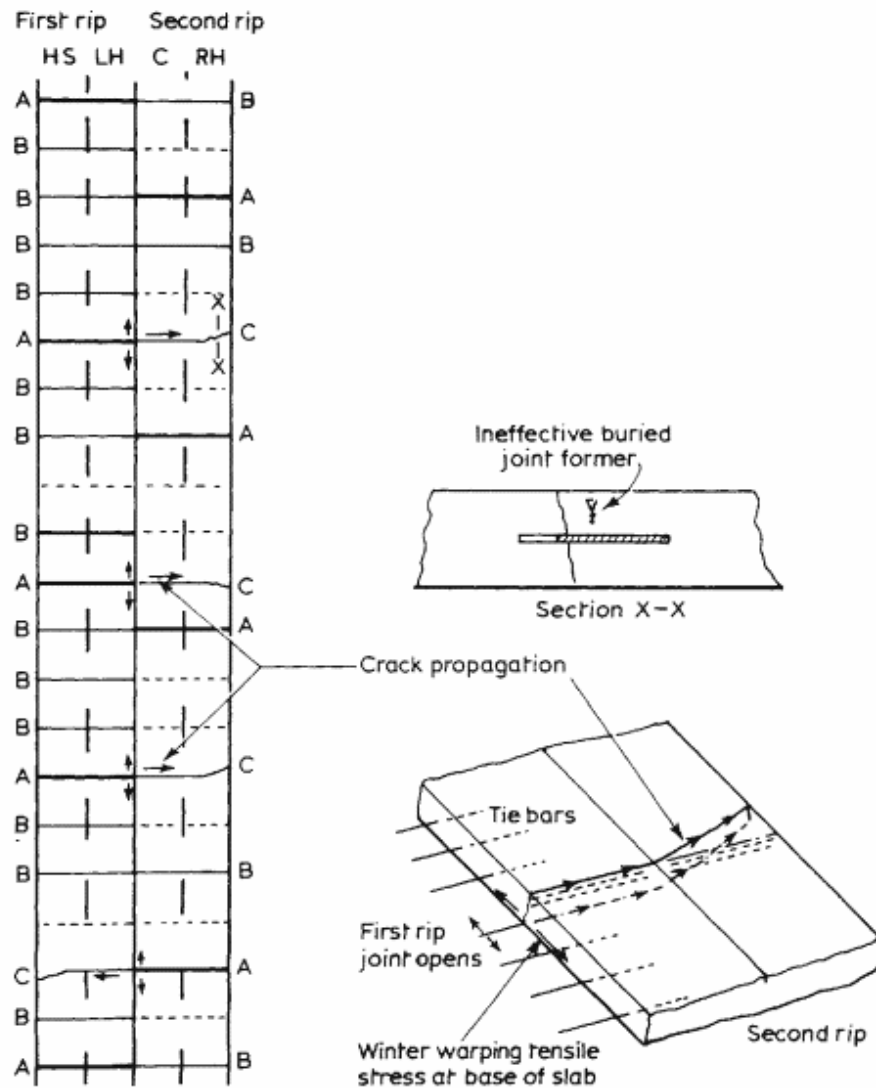
Fig. 10.8 Sympathetic cracking at joints: A, joints cracked as a result of initial shrinkage of concrete on hardening; these joints tend to have greater movement; B, additional joints cracking later, due to seasonal reduction in temperature or diurnal warping, together with construction traffic loading; C, cracks forming at joint positions in second rip as a result of the influence of movement or joints in the first rip without a proper discontinuity or notch in the top of the slab.

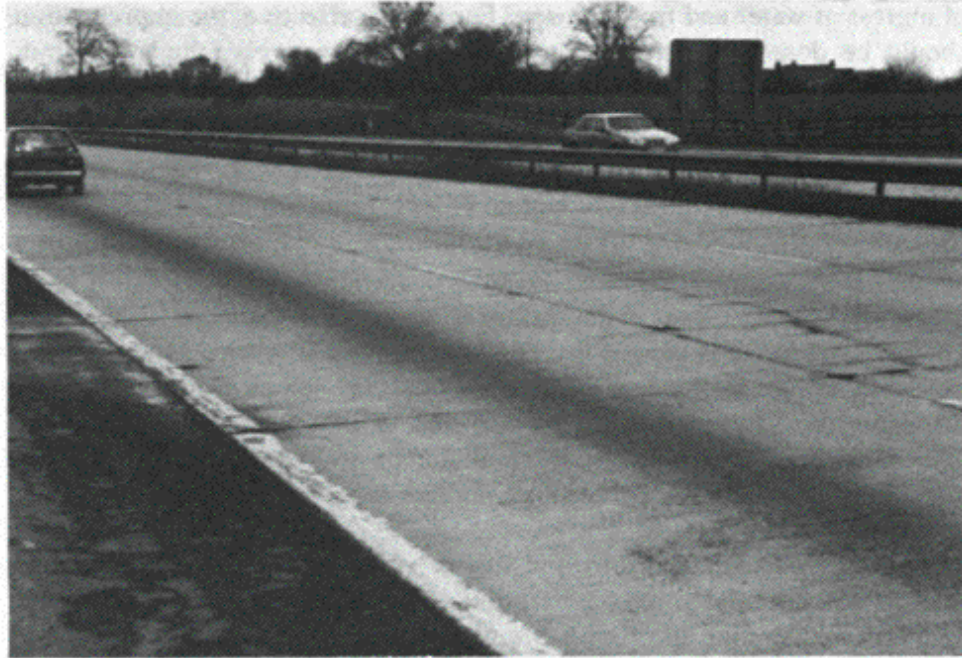
Fig. 10.9 Stitched crack.

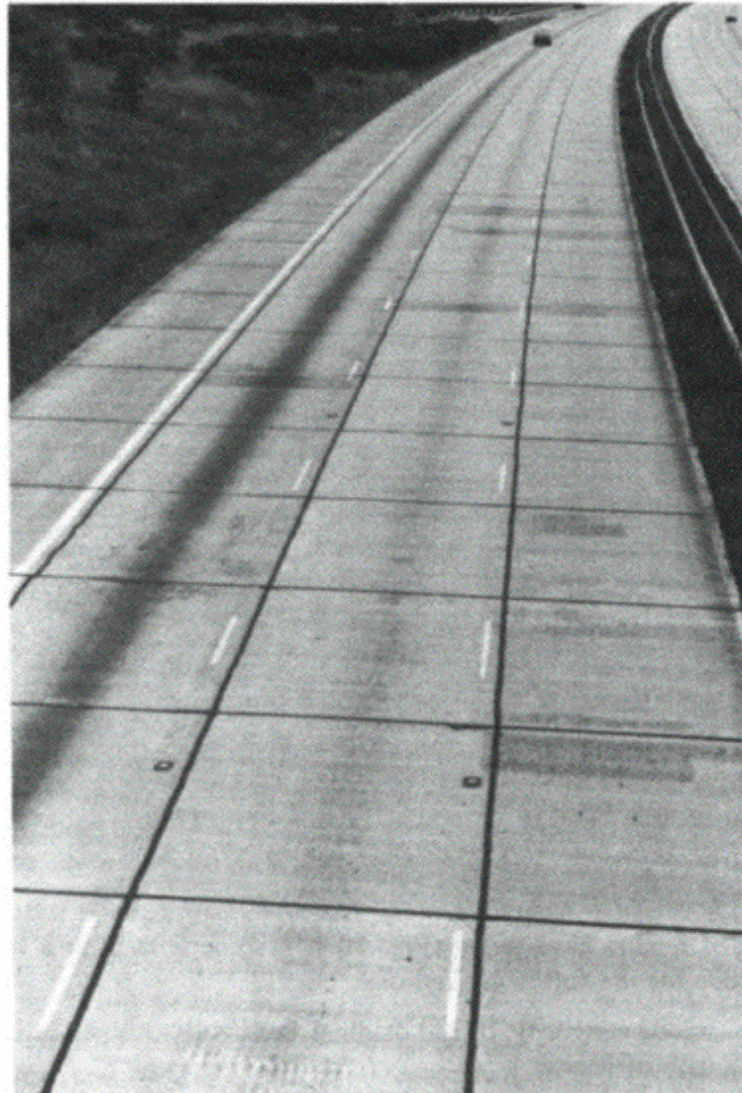
Fig. 10.10 Overhand sealing of joints.

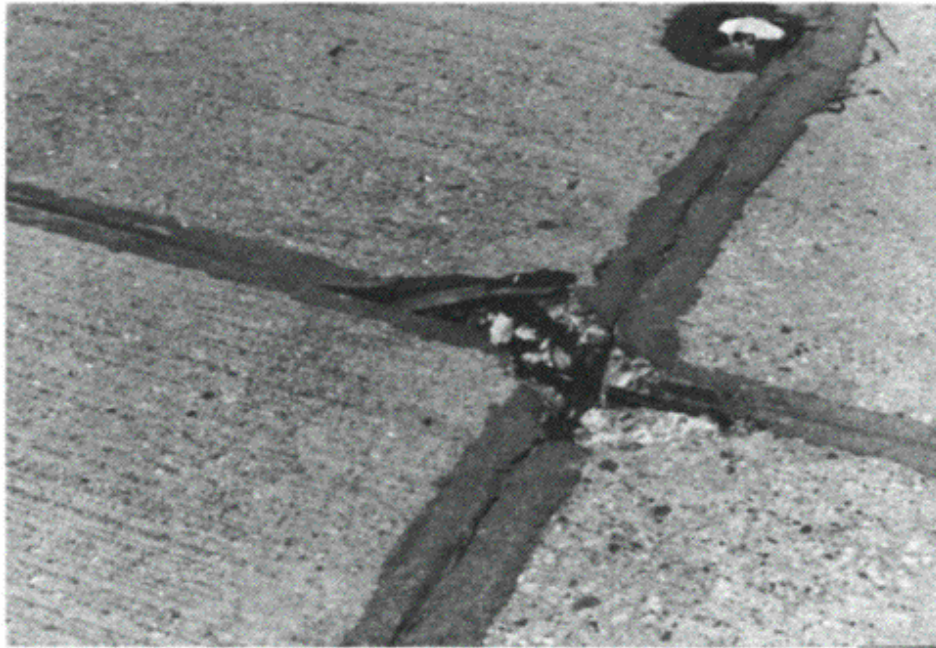
Fig. 10.11 Ineffectiveness of overbanding

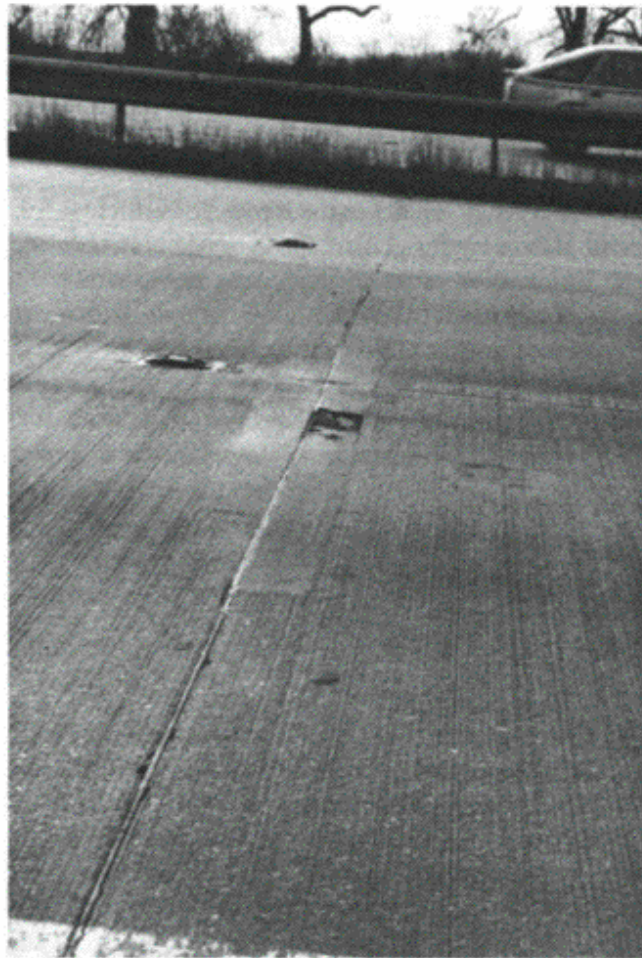
Fig. 10.12 Failed arris repair
